LAC MINERALS FINAL RECLAMATION INSPECTION PHOTOGRAPHS

Area: Spruce Gulch

Date: 8/18/10

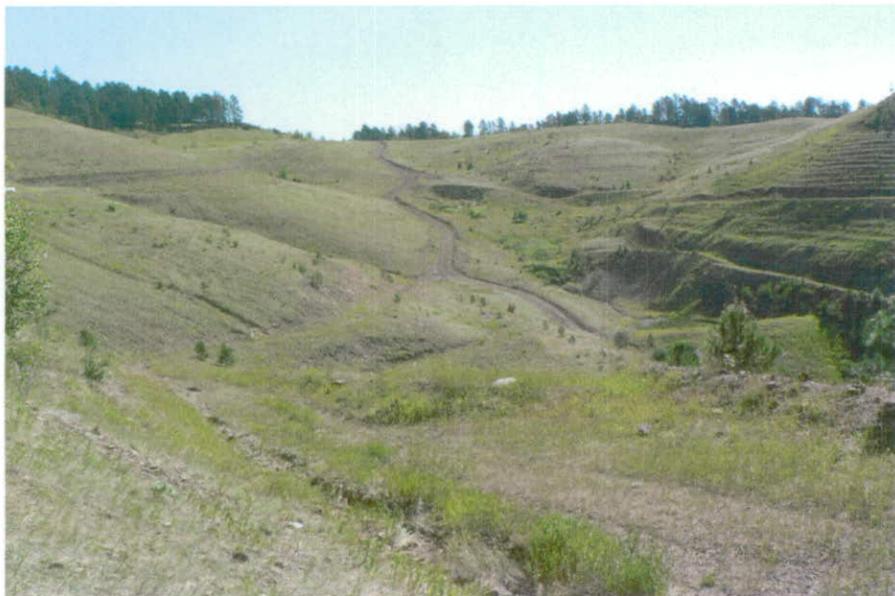
Photo SG-1 – View of Spruce Gulch, looking southeast.

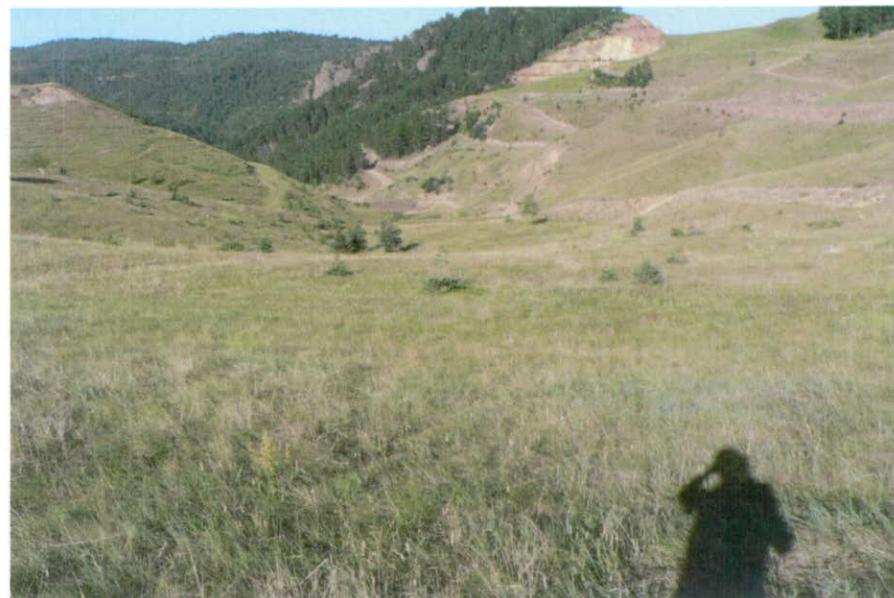
Photo SG-2 – View of Spruce Gulch, looking west.

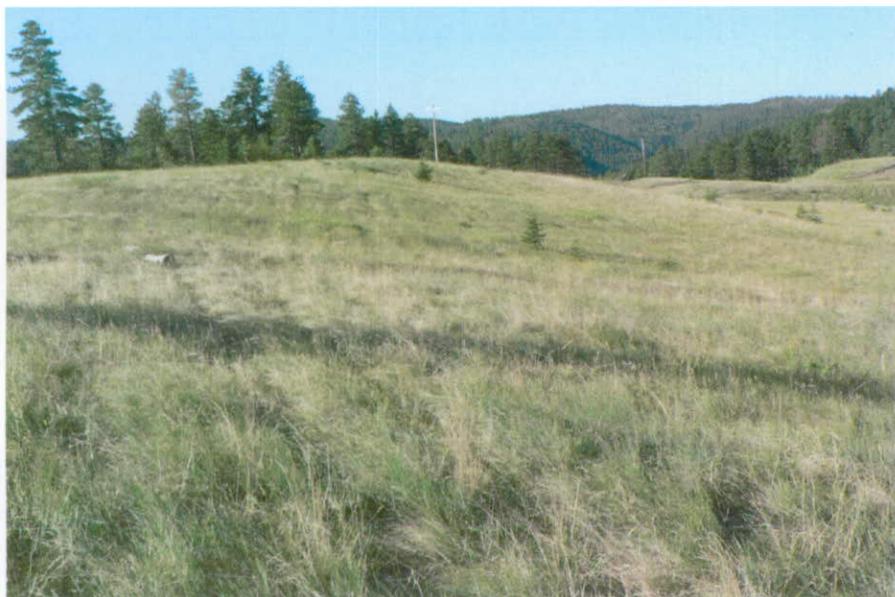
Photo SG-3 – Vegetative cover in Spruce Gulch.

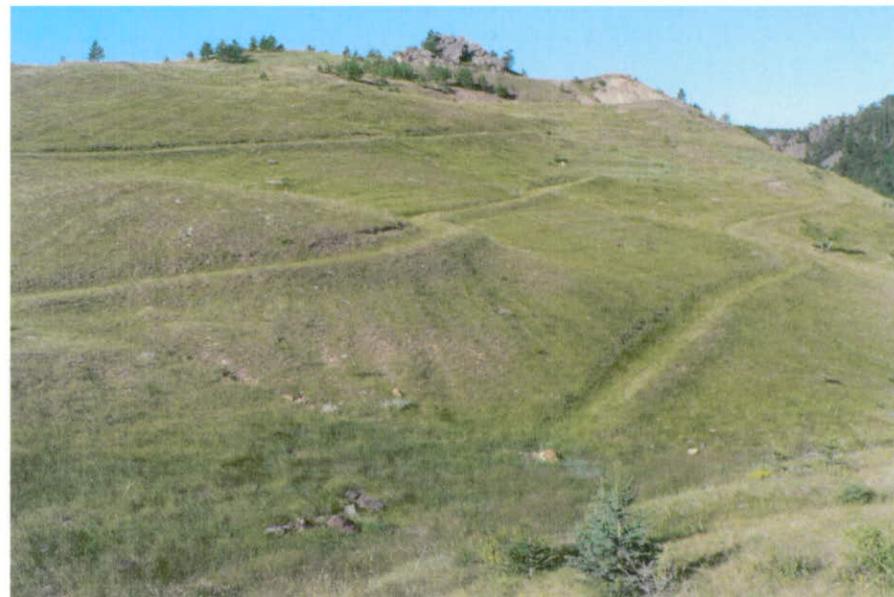
Photo SG-4 – Vegetative cover on reclaimed hillside.

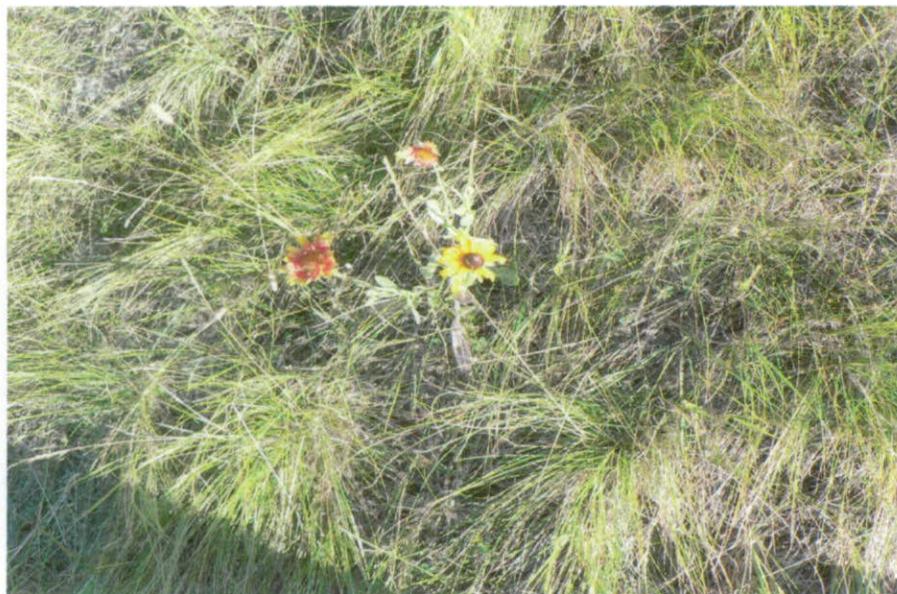
Photo SG-5 – Black-eyed susan and blanket flower on reclaimed area.

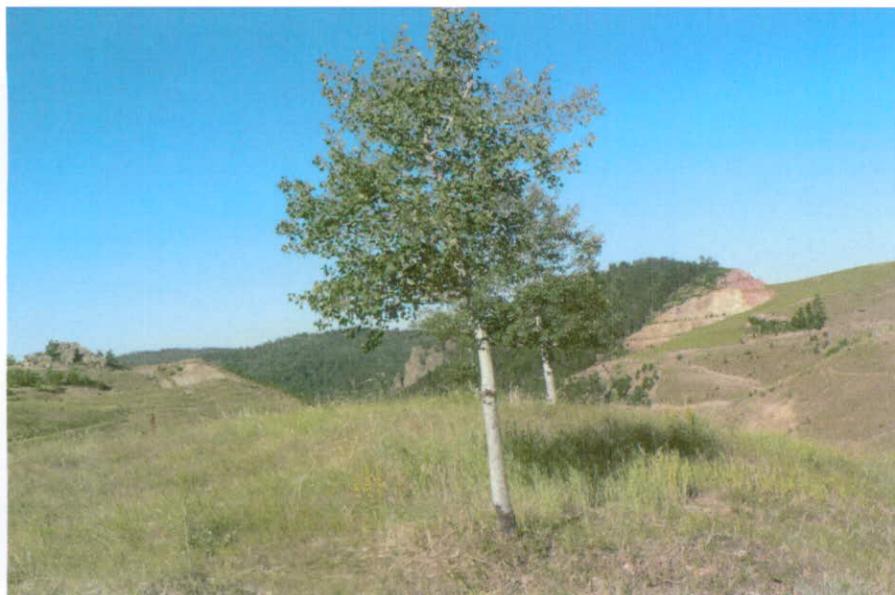
Photo SG-7 – Transplanted aspen in Spruce Gulch.

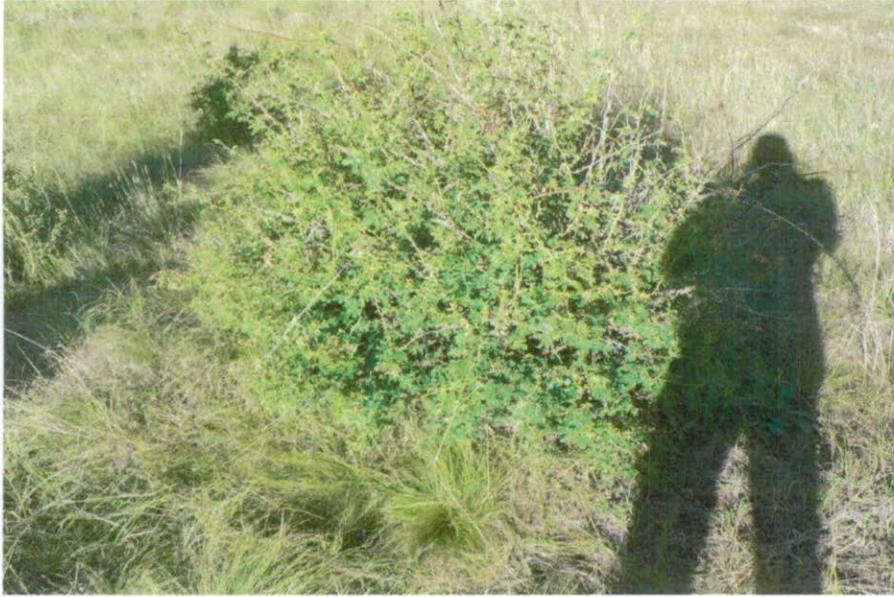
Photo SG-9 – Healthy woods rose in reclaimed area.

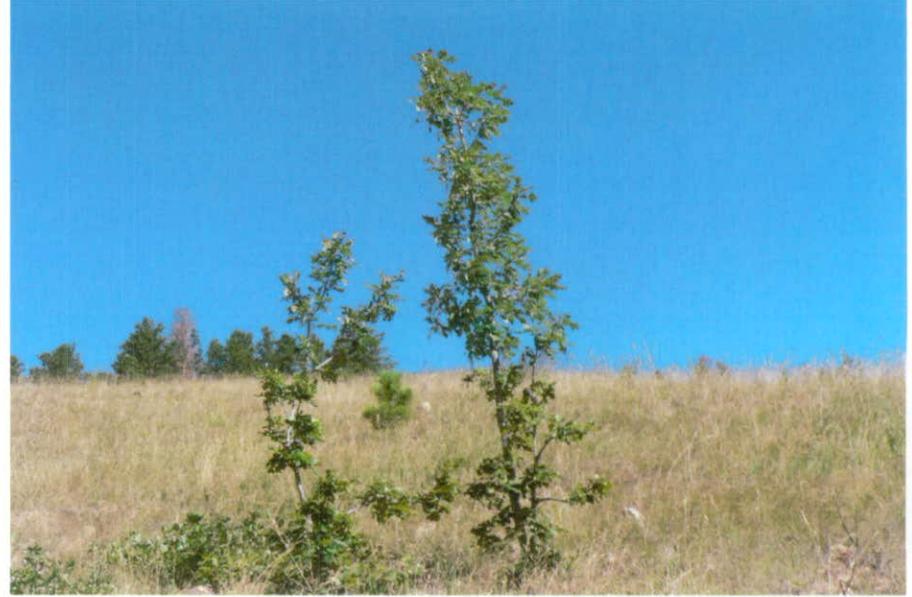
Photo SG-10 – Healthy bur oak in reclaimed area.

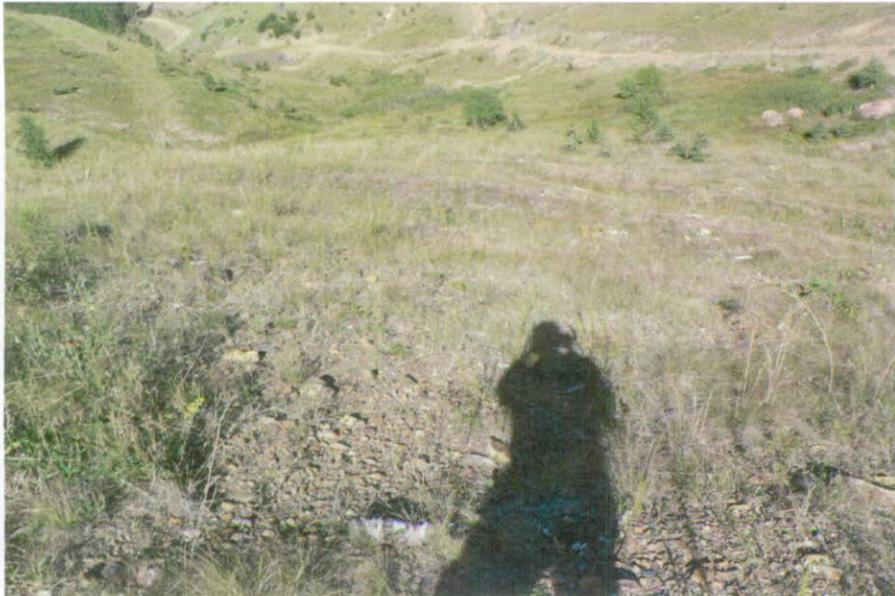
Photo SG-11 – Reclaimed sawdust area.

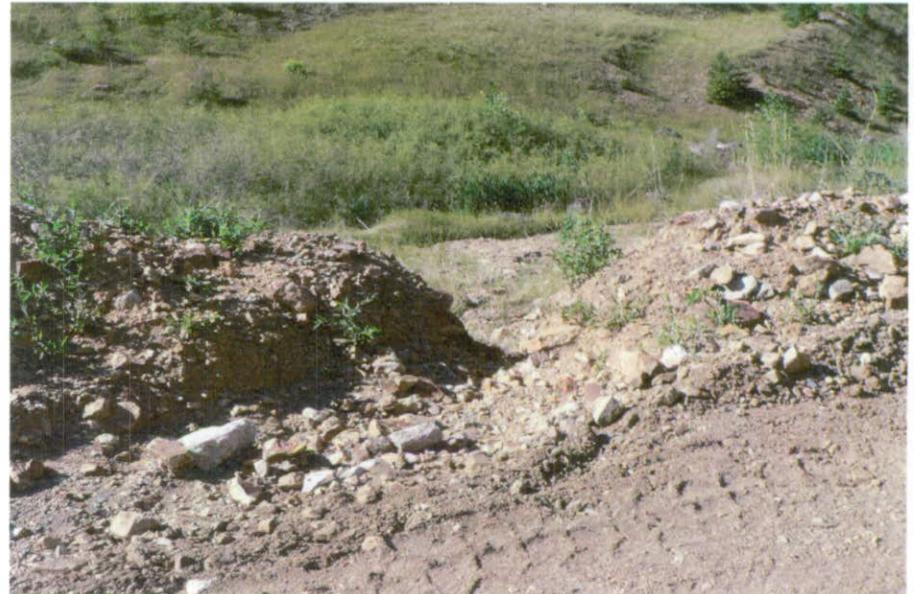
Photo SG-14 – Washout along road.

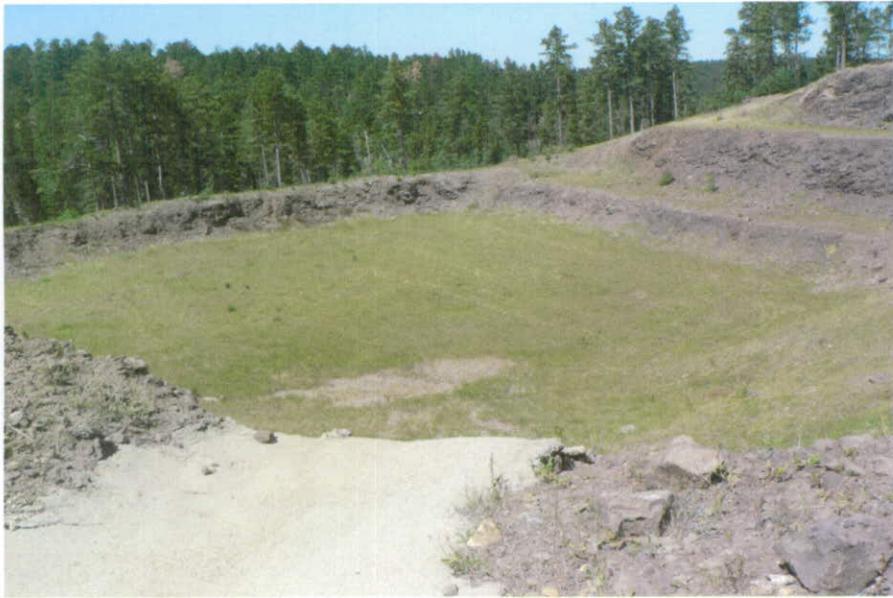
Photo LQ-1 – Limestone Quarry No. 1.

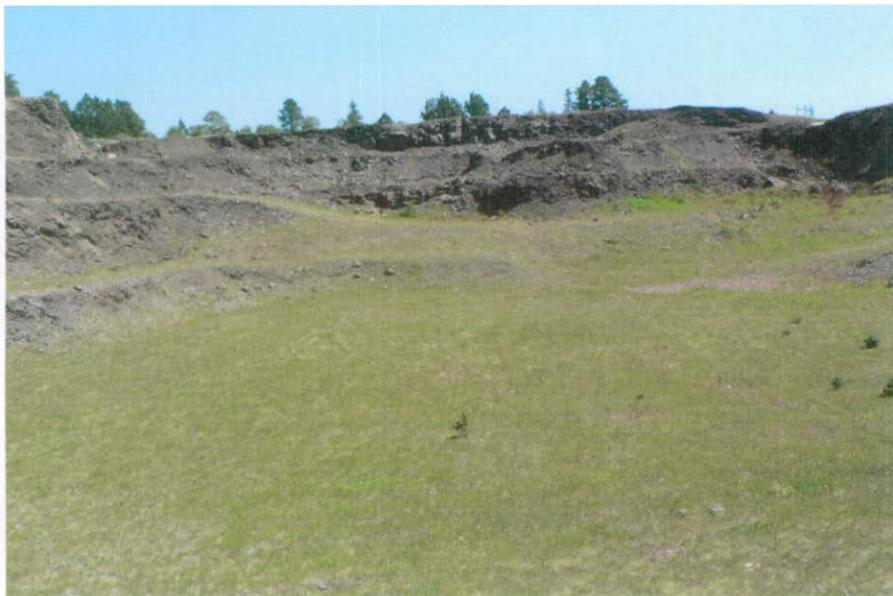
Photo LQ-3 – Vegetative cover on floor of Limestone Quarry No. 1.

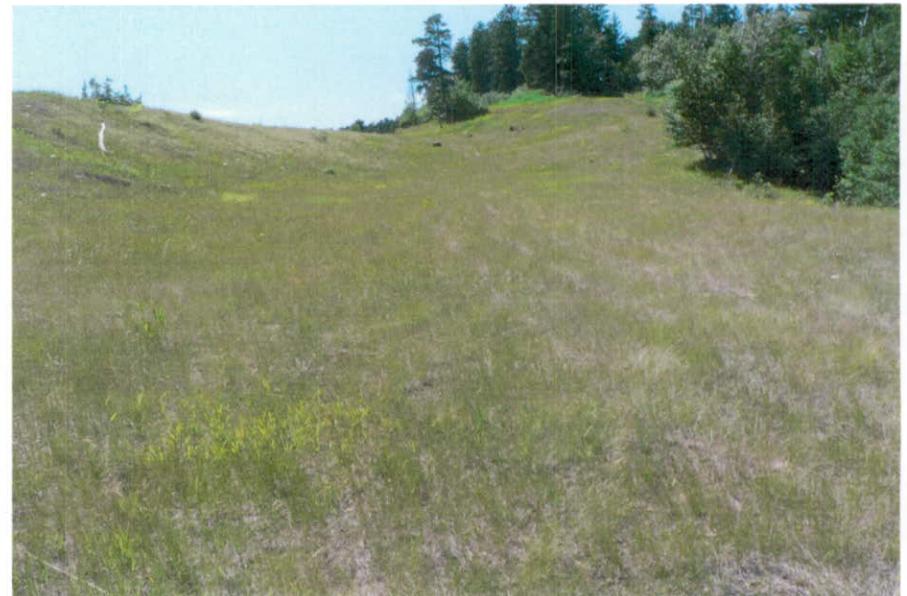
Photo LQ-4 – Vegetative cover at west end of Limestone Quarry No. 1.

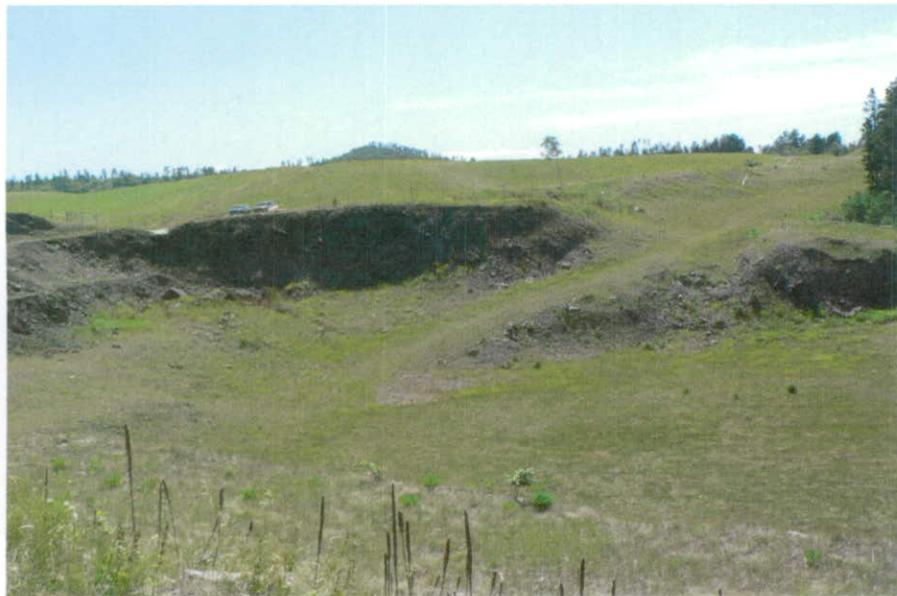
Photo LP3-1 – View of Leach Pad No. 3 from Limestone Quarry No. 1.

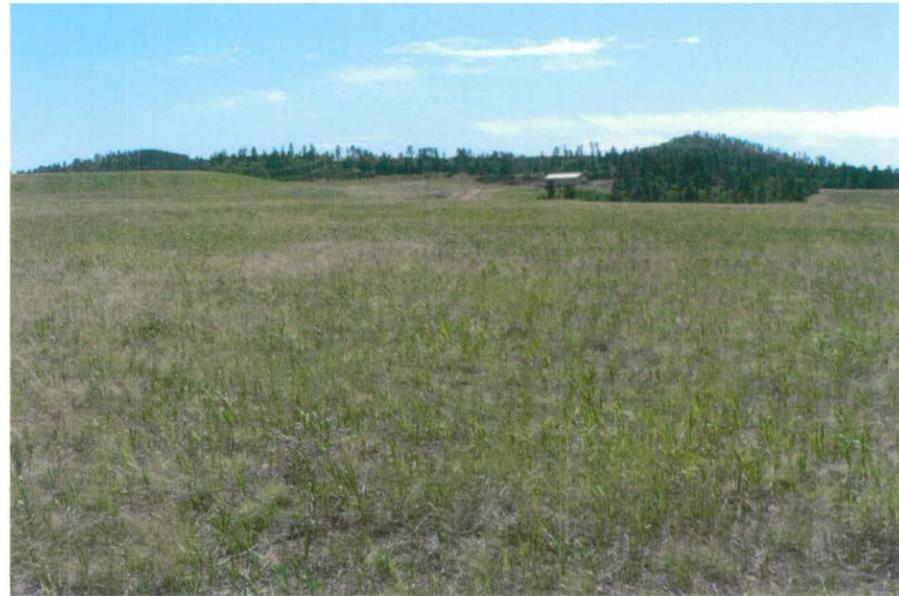
Photo LP3-2 – Vegetative cover on top of Leach Pad No. 3, looking southwest.

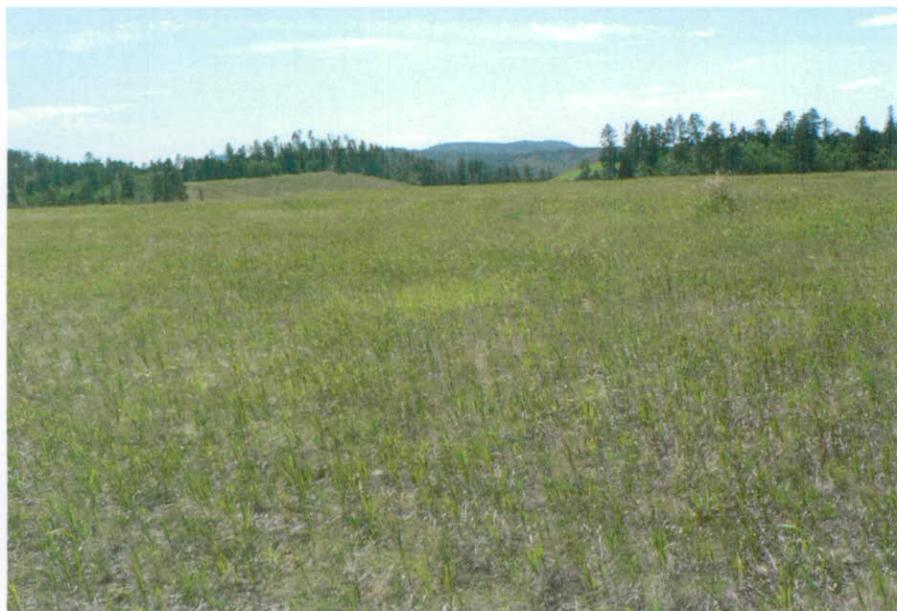
Photo LP3-3 – Vegetative cover on top of Leach Pad No. 3, looking west.

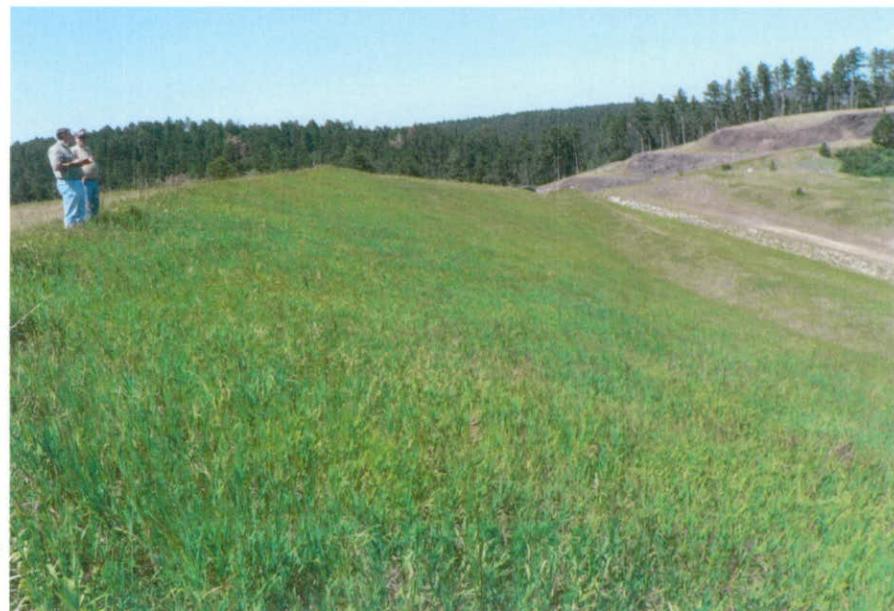
Photo LP3-4 – Vegetative cover on side slope of Leach Pad No. 3.

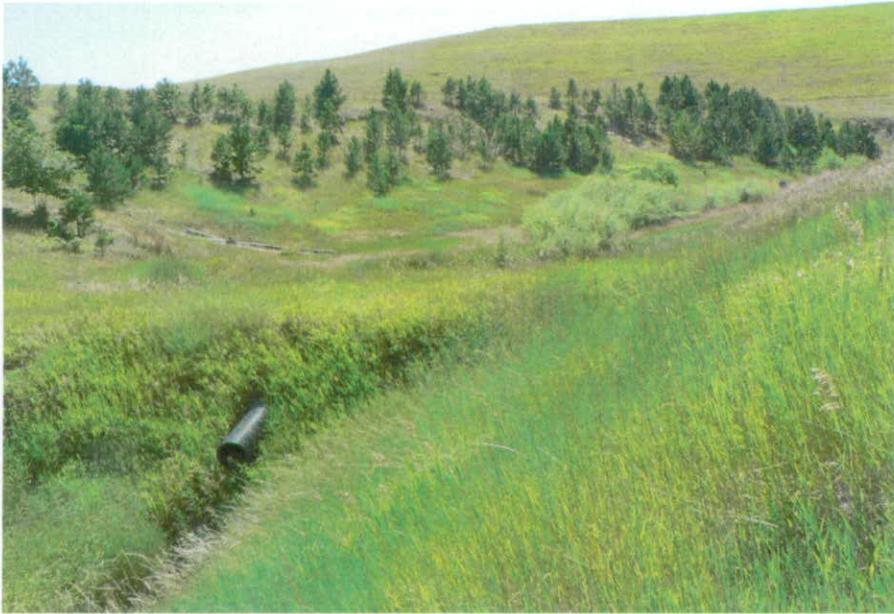
Photo LPC-5 – HDPE culvert.

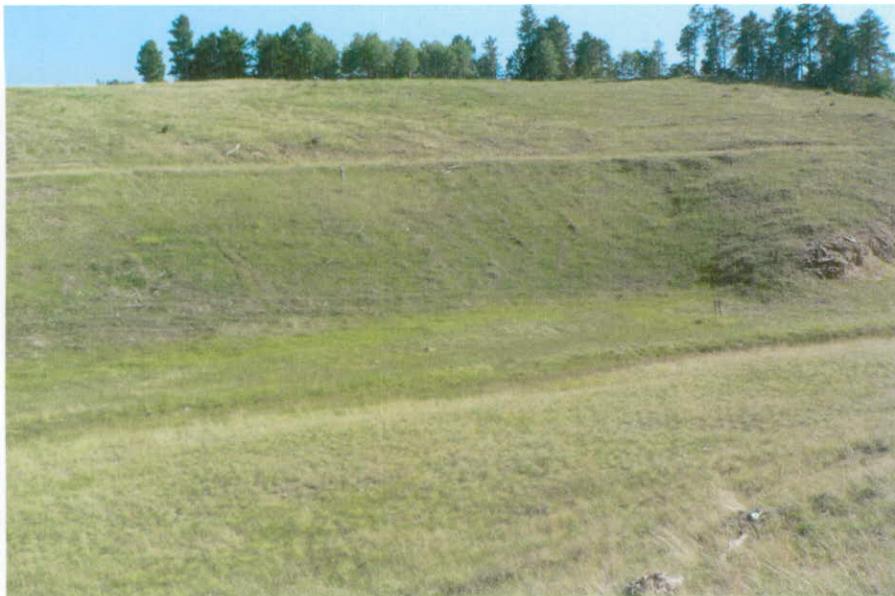
Photo VN-3 – Vegetative cover on V-Notch slope.

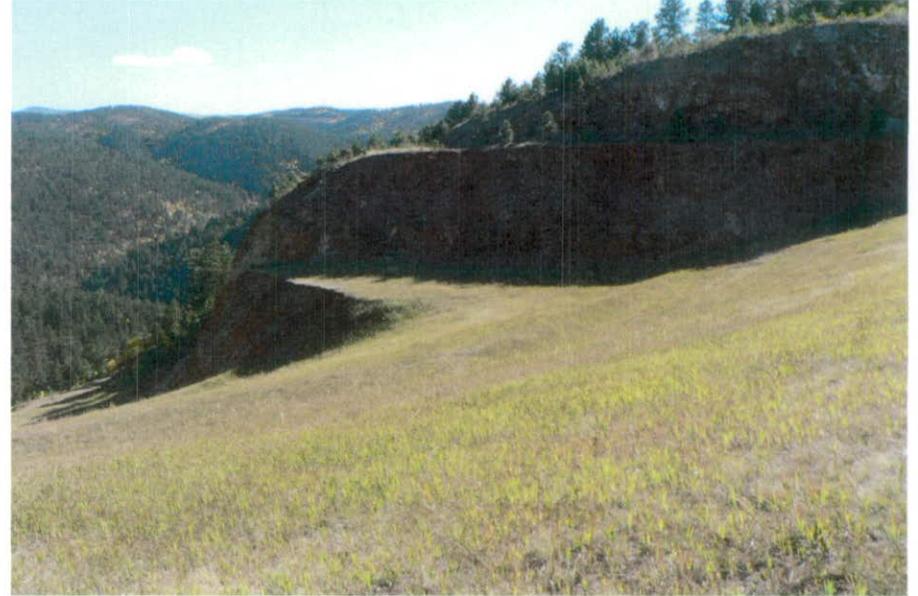
PhotoLPI-6 – Northwest pit highwall.

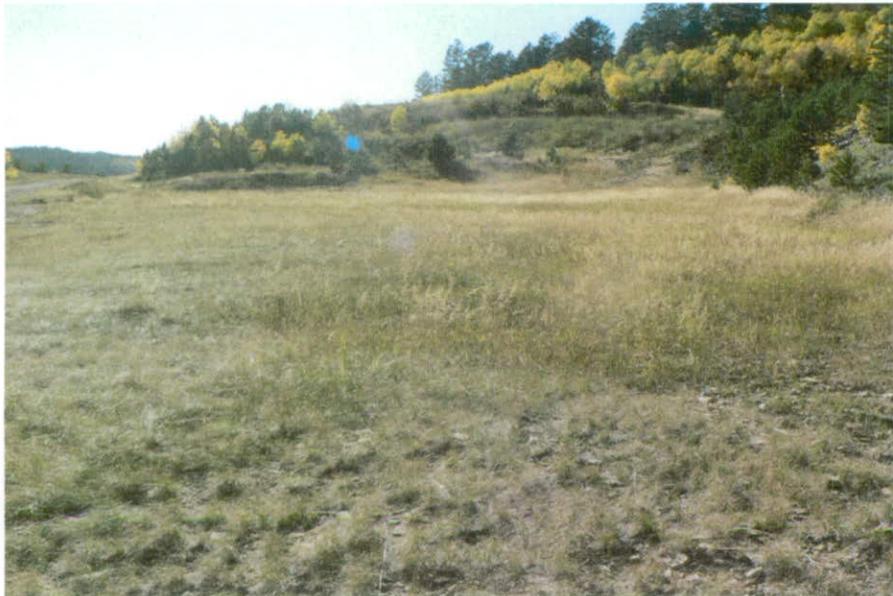
Photo HR-3 – Reclaimed fuel storage area.

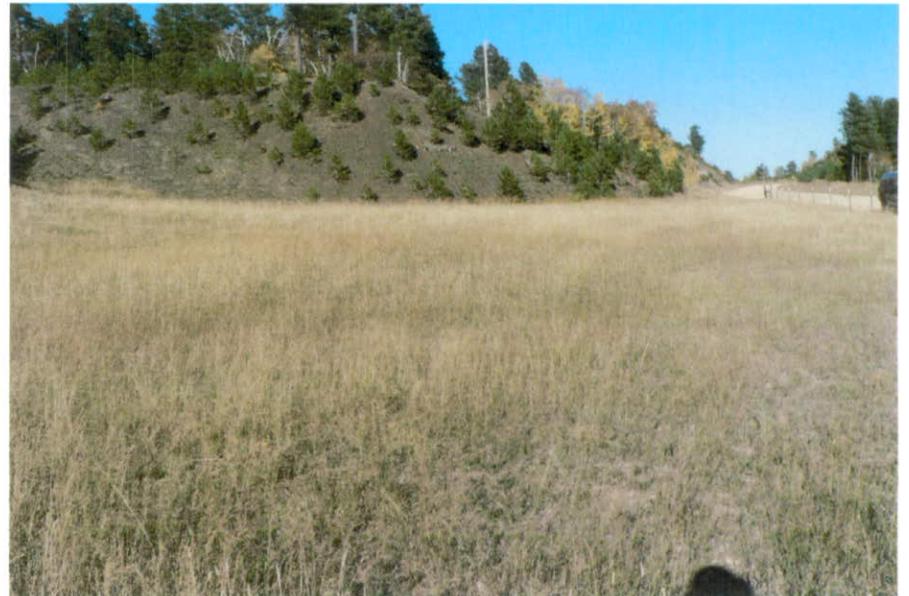
Photo HR-4 – Portion of fuel storage area to be redisturbed during reconstruction of access road.

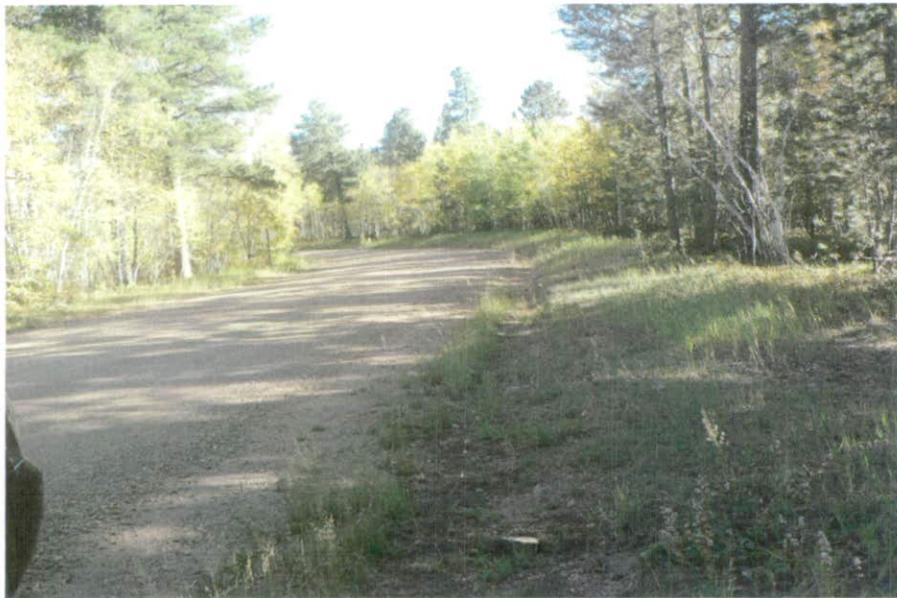
Photo AR-1 – Reclaimed access road cut and fill areas.

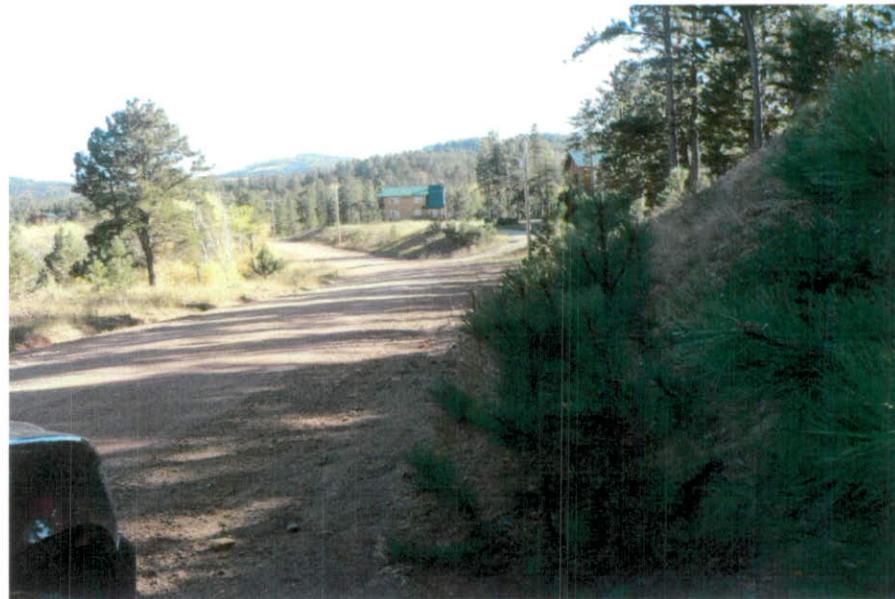
Photo AR-2 –Reclaimed access road cut slopes.

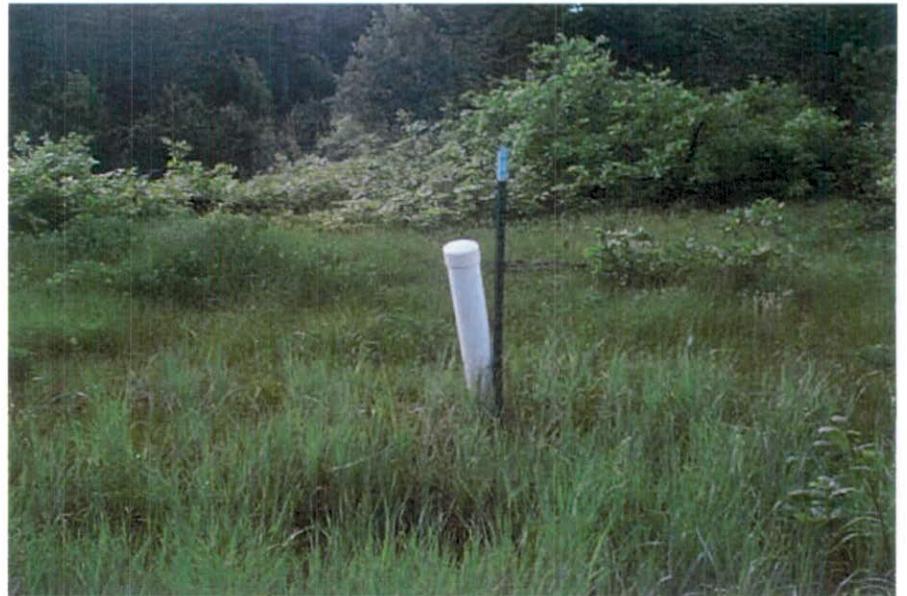
Photo LA-4 – Vegetative cover in the Land Application area.

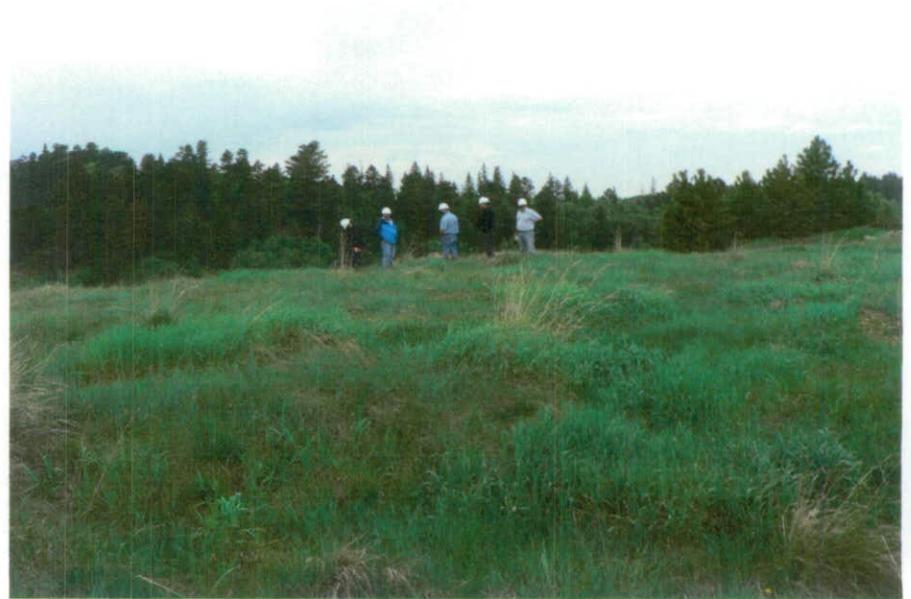
Photo PT-2 – Vegetative cover from June 10, 2015 inspection.
