LAC Minerals
2013 Annual Environmental Audit and Inspection Report

Operator: LAC Minerals (USA) LLC, Richmond Hill Mine
Project: Annual Environmental Audit and Inspection
DENR Inspectors: Mike Cepak, Eric Holm, Mark Keenihan, Roberta Hudson, and Matt Hicks
Operators Present: Todd Duex, Gene Fuller, and Mark Tieszen
Others Present: Stan Michals, SD Game, Fish and Parks
Inspection Dates: June 18 and 19, 2013
Time In/Out: June 18, 2013: 11:20 am MDT to 1:00 pm MDT
June 19, 2013: 10:30 am MDT to 4:40 pm MDT

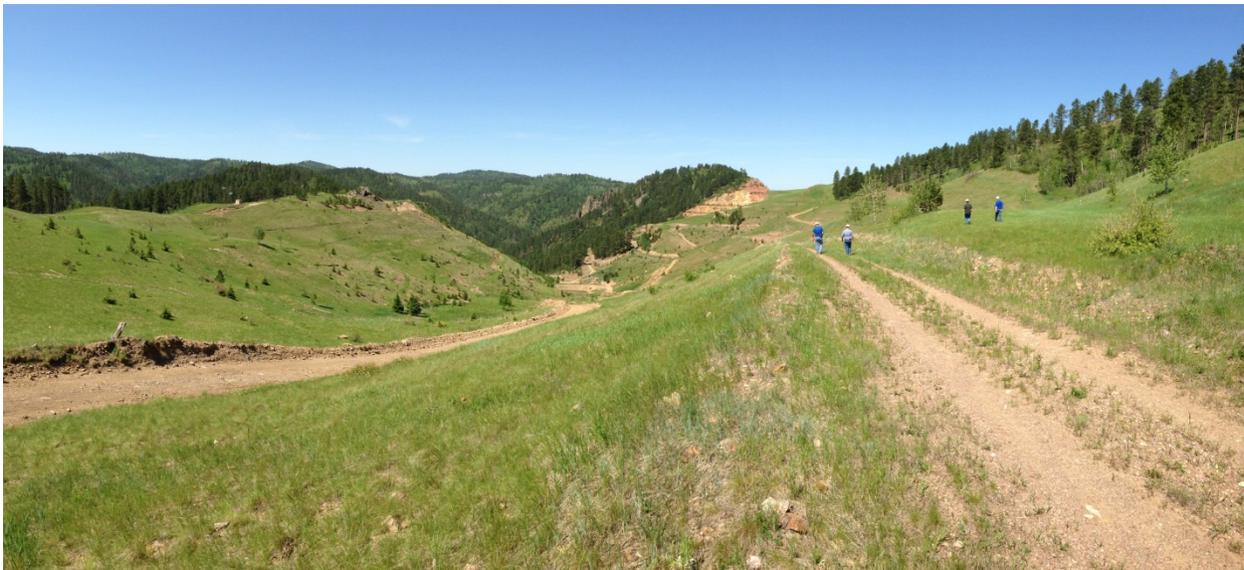
Vegetative cover in Spruce Gulch is now in its seventeenth growing season and continues to be very good to excellent. No new erosion was noted. LAC established four vegetation transects in Spruce Gulch (SGHER#1, SGHER#2, SGHER#3, and SGHER#4) and collected data in 1997, 1998, 1999, 2000, 2005, and 2010. Live vegetative cover in SGHER#1 varied from a low of 53 percent in 1999 to a high of 84 percent in 2010 and averaged 64 percent over the monitoring period. Live vegetative cover in SGHER#2 varied from a low of 62 percent in 2000 and 2005 to a high of 82 percent in 1997 and averaged 71 percent over the monitoring period. Live vegetative cover in SGHER#3 varied from a low of 45 percent in 1997 to a high of 60 percent in 2005 and averaged 52 percent over the monitoring period. Live vegetative cover in SGHER#4 varied from a low of 59 percent in 1997 to a high of 79 percent in 2010 and averaged 69 percent over the monitoring period. The overall average of 64 percent for the monitoring period exceeds the 40 percent cover standard established for the mine site.

Average vegetative cover in the area evaluated was estimated at 60 percent which is close to the overall average and above the 40 percent cover standard. Grasses and legumes present that are part of the approved seed mix include timothy, kentucky bluegrass, smooth brome grass, slender and western wheatgrass, hard fescue, white dutch clover, blanket flower, rocky mountain

Photo 1. Spruce Gulch looking west towards pit impoundment.

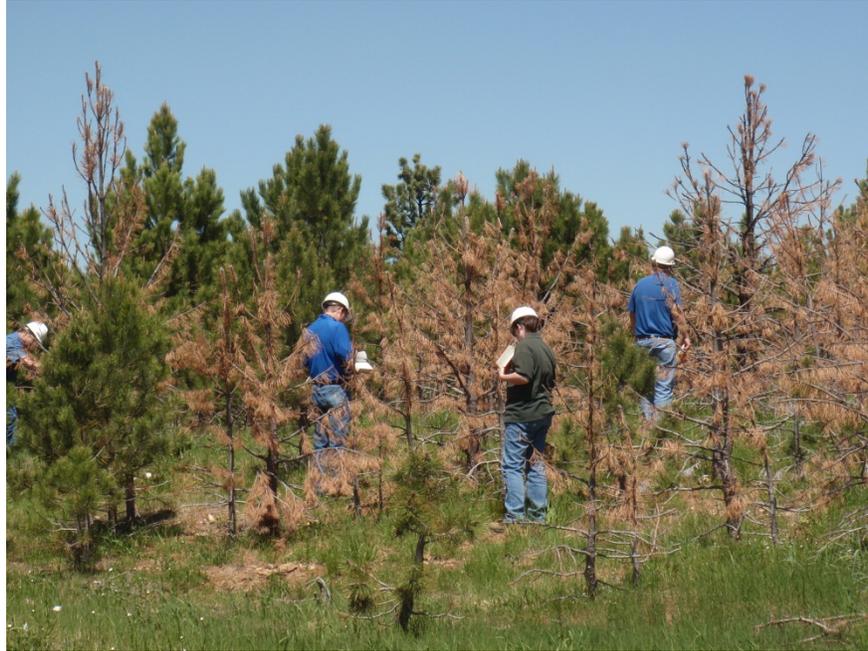
The area has become a mixed ponderosa pine forest with some black hills spruce, aspen, birch and assorted shrubs. We noted numerous small pine trees likely killed by bark beetles (“ips”). For the most part the dead trees ranged from 8 to 12 feet in height. We noted the beetle holes in the tree bark and we pulled off pieces of bark to inspect the damage done by the beetles. Shrubs and other understory species noted include serviceberry, juniper, and chokecherry. LAC has not collected any tree and shrub data in this area.

Photo 2. Dead bark beetle trees in Turn Around area.

11. Weed Control. Gene Fuller said that Mid Dakota would be out this summer spraying weeds along the powerlines. He mentioned that pine trees were dying in “patches” in the Turnaround area. Holes in the bark indicated a probable bark beetle infestation.

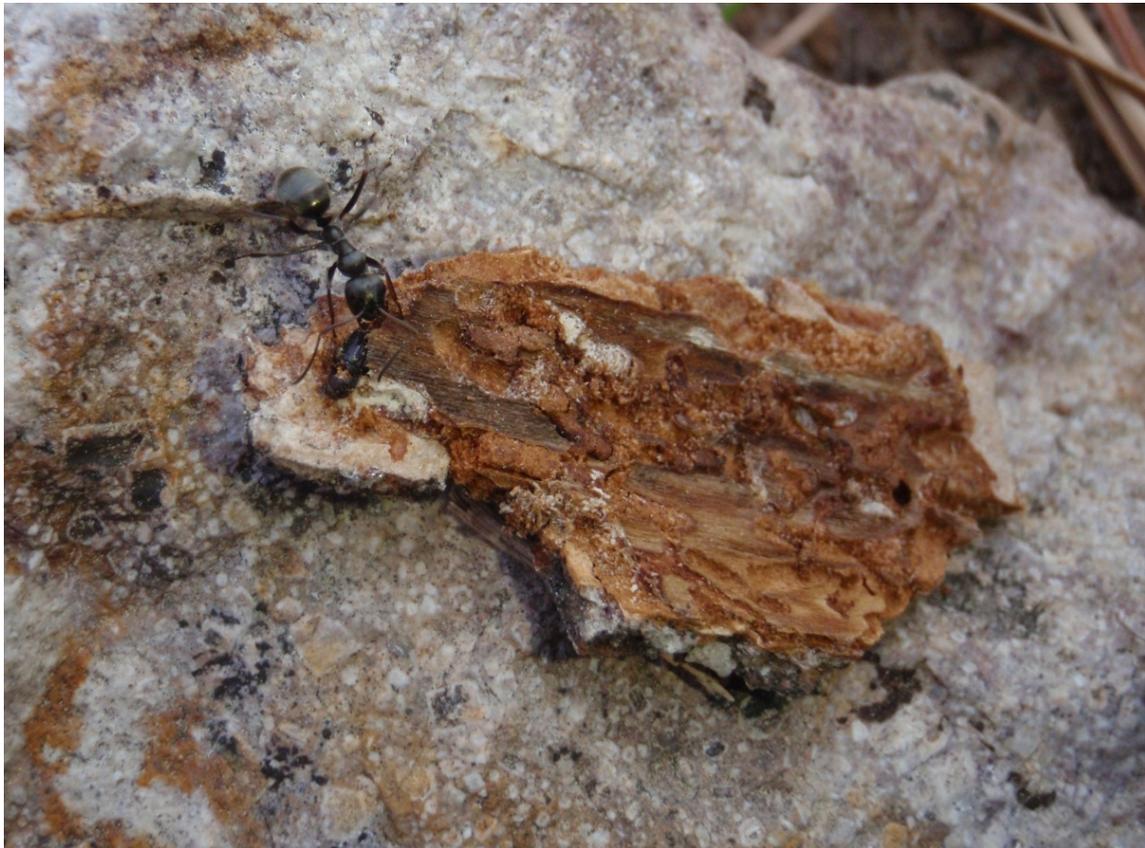
Photo 3. Bark beetle or “ips” (next to the head of the ant) on a piece of bark from an affected tree. Note the beetle channel marks on the bark

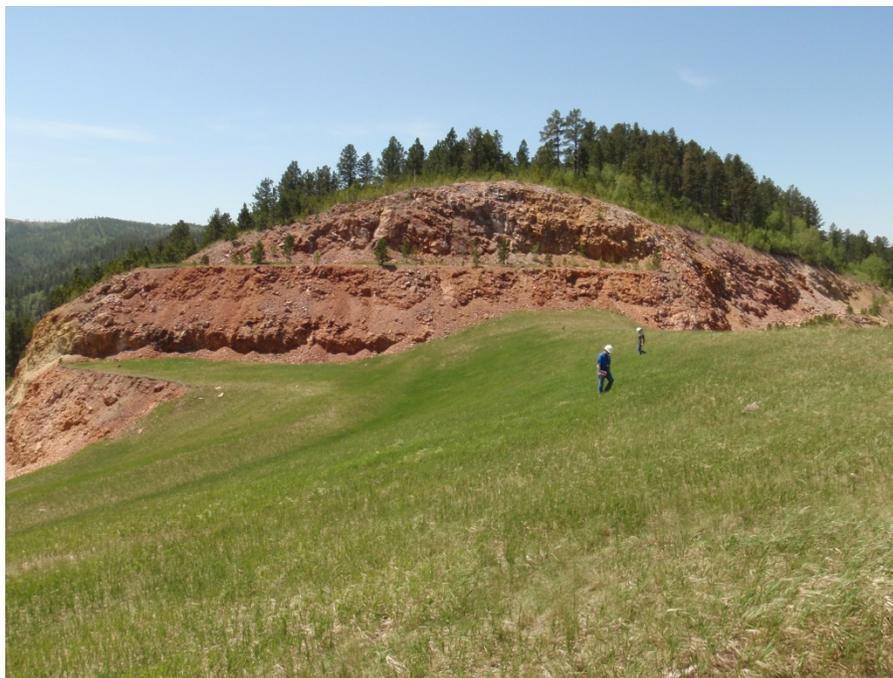
Pit Impoundment: The inspection group arrived at the top of the Pit Impoundment at 11:44 am MDT. Vegetative cover on the pit impoundment is now in its eighteenth growing season and continues to be very good to excellent. No new erosion was noted. LAC established four vegetation transects on the pit impoundment (PI#1, PI#2, PI#3, and PI#4) and collected data from 1997 through 2012. Live vegetative cover in PI#1 varied from a low of 50 percent in 2002 to a high of 79 percent in 2003 and averaged 63 percent over the 16 year monitoring period. Live vegetative cover in PI#2 varied from a low of 46 percent in 2002 to a high of 72 percent in 2003 and 2004 and averaged 58 percent over the 16 year monitoring period. Live vegetative cover in PI#3 varied from a low of 43 percent in 2002 to a high of 71 percent in 2003 and averaged 56 percent over the 16 year monitoring period. Live vegetative cover in PI#4 varied from a low of 38 percent in 2009 to a high of 57 percent in 2004, 2005, and 2007 and averaged 50 percent over the 16 year monitoring period. The overall average of 57 percent for the 16 year monitoring period exceeds the 40 percent cover standard established for the mine site.

Photo 4. Top of Pit Impoundment, looking west.

Average vegetative cover was estimated at 55 percent which is close to the overall average and above the 40 percent cover standard. Grasses and legumes present that are part of the approved seed mix include kentucky bluegrass, smooth brome, western wheatgrass, hard fescue, white dutch clover, blue flax, and rocky mountain penstemon. Other species present include black medic, goatsbeard, assorted vetches, moss, field pussytoes, violets, and yarrow. Noxious and other weeds present include St. Johns wort, canada thistle, tansy, and houndstongue. A small patch of raspberry was noted near the toe drain area. LAC also removed a small aspen seedling from the impoundment during the inspection. The company needs to continue to remove pine trees from the impoundment and spray ceanothus.

1. LAC continues to do a very good job of reclamation and site-wide environmental management.
2. LAC needs to continue spraying St. John's wort, spotted knapweed, and other noxious weeds in areas covered by the mine permit.
3. LAC needs to continue removing pine trees, ceanothus, and other deep rooting vegetation from the pit impoundment and leach pad areas of the mine.

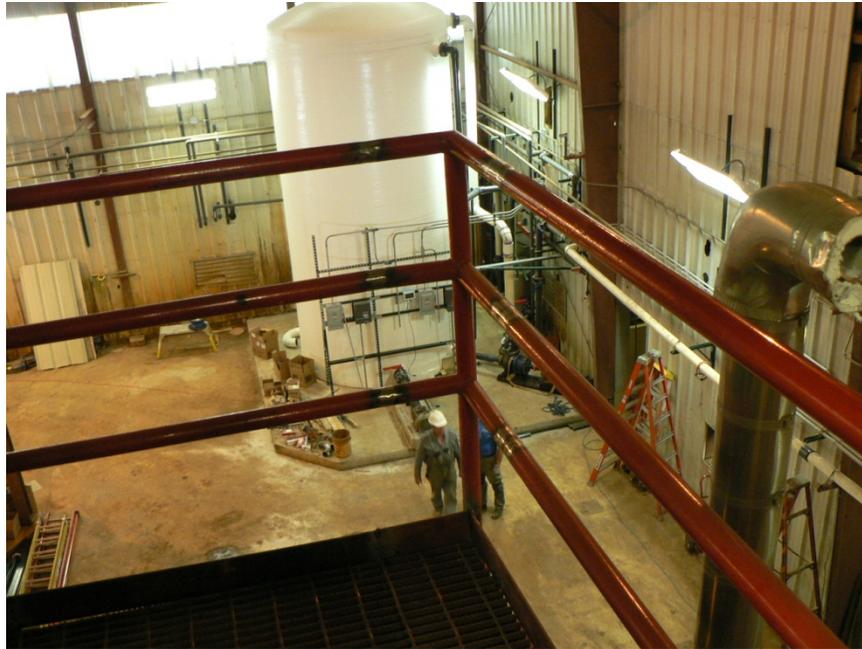
Water Treatment Plant (WTP): At 12:50 pm MDT, we entered the WTP. The old carbon tanks (more recently used as water treatment tanks) have been removed. Parts of the main floor of the process building are being remodeled, and a new laboratory and bathroom is being constructed.

The reverse osmosis (RO) unit in the trailer on the north side of the building is still in use, but the new RO and RO feed tank will be in the main building. The old RO will be replaced in the near future. The biological plant installed in 2011 continues to operate.

Photo 5: Interior of Process Plant after carbon tanks removed.

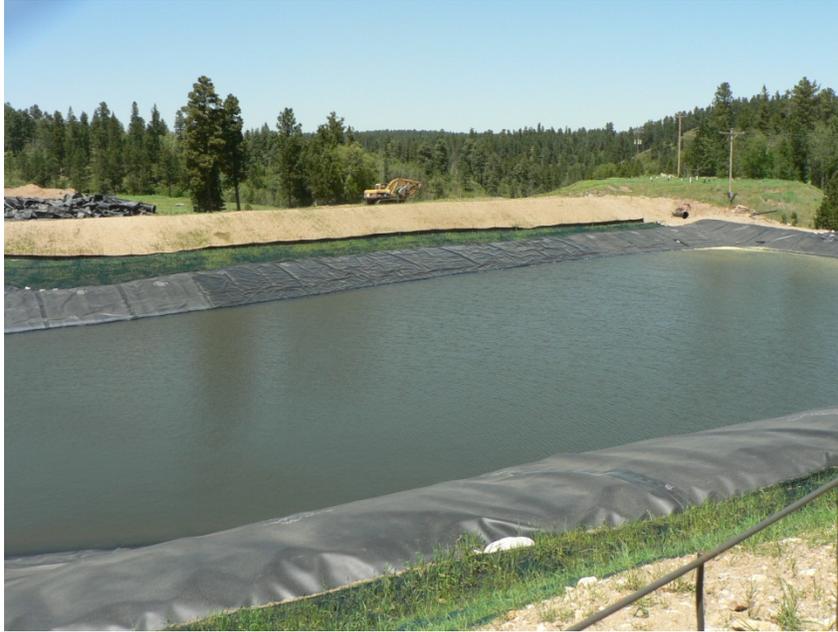
Pregnant Pond and New Sludge Pond: At 1:15 pm MDT, we walked outside the WTP and checked the Pregnant Pond and new Sludge Pond (old Barren Pond). LAC completed relining the Pregnant Pond in 2012. Most of the Pregnant Pond was lined with textured liner. LAC also installed a new Pregnant Pond pump house with two pumps (for redundancy). On the west side of the pond, the slope above the pond liner was regraded and seeded. Jute netting was placed on the slope to aid in vegetation establishment. Some first season growth was noted.

Photo 6. Relined Pregnant Pond.

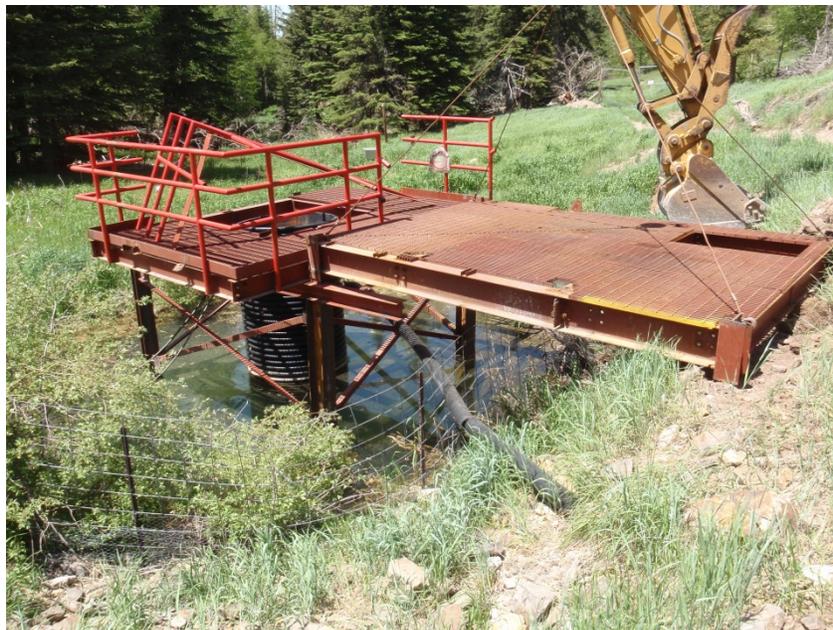
FD-1: At 1.29 pm MDT we stopped by the FD-1 area. A construction crew was at the FD-1 site and was in the process of installing a platform over a new manhole. Later, a new pump house will be built over the manhole. The pump will be operated remotely. A new buried pipeline from FD-1 is being built along the access road to the Pregnant Pond. A buried discharge pipeline is also being constructed in the same trench and will run from the Water Treatment Plant to the frog pond. Treated water will be discharged into the upper end of the frog pond to the south of the new pump house. The pipes will be buried below the frost line to prevent freezing during wintertime operations.

Photo 7. New platform installed over FD-1.

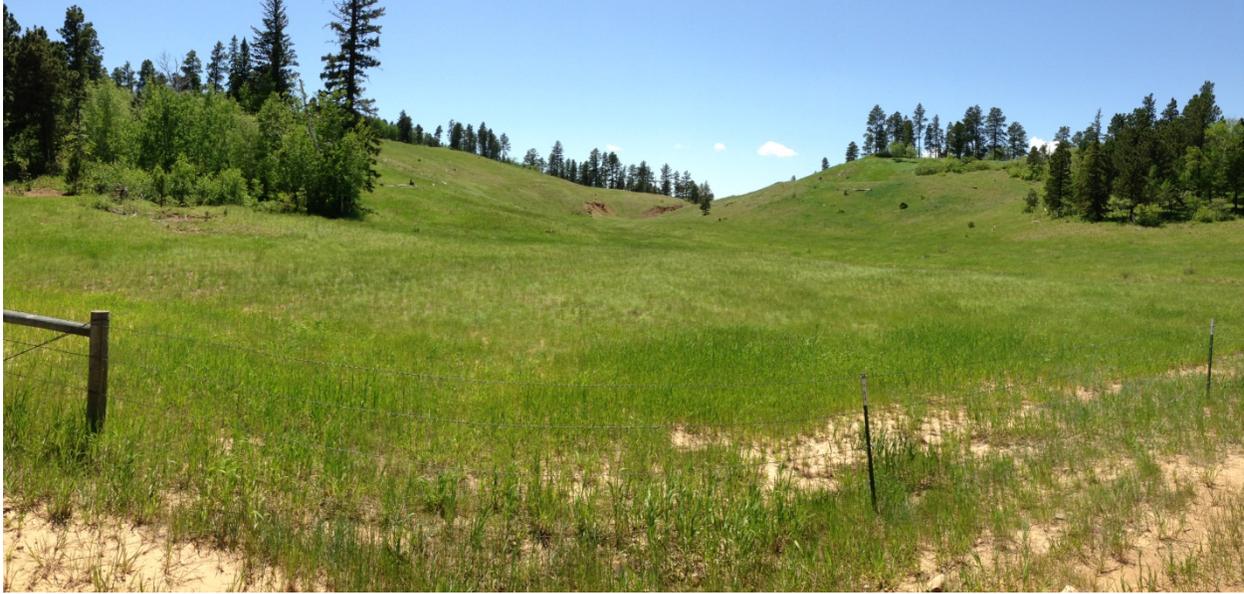
V-Notch Area: We arrived at the V-Notch area at 1:53 pm MDT. Vegetative cover on the V-Notch area is in its sixteenth growing season and continues to be very good to excellent. No new erosion was noted. LAC Minerals established two vegetative transects in the V-Notch (VN-1 and VN-2) and collected vegetation data from the transects from 1997 through 2000 and in 2005 and 2010. Live vegetative cover in VN-1 varied from a low of 45 percent in 1997 to a high of 83 percent in 1999 and averaged 69 percent over the monitoring period. Live vegetative cover in VN-2 varied from a low of 49 percent in 1997 to a high of 75 percent in 2010 and averaged 64 percent over the monitoring period. The overall average of 67 percent for the monitoring period exceeds the 40 percent cover standard established for the mine site.

Some water was noted in the drainage channel during the inspection. Also, some minor acid seeps were noted along the cut in the western end of the V-Notch.

Photo 8. V-notch area 2013.

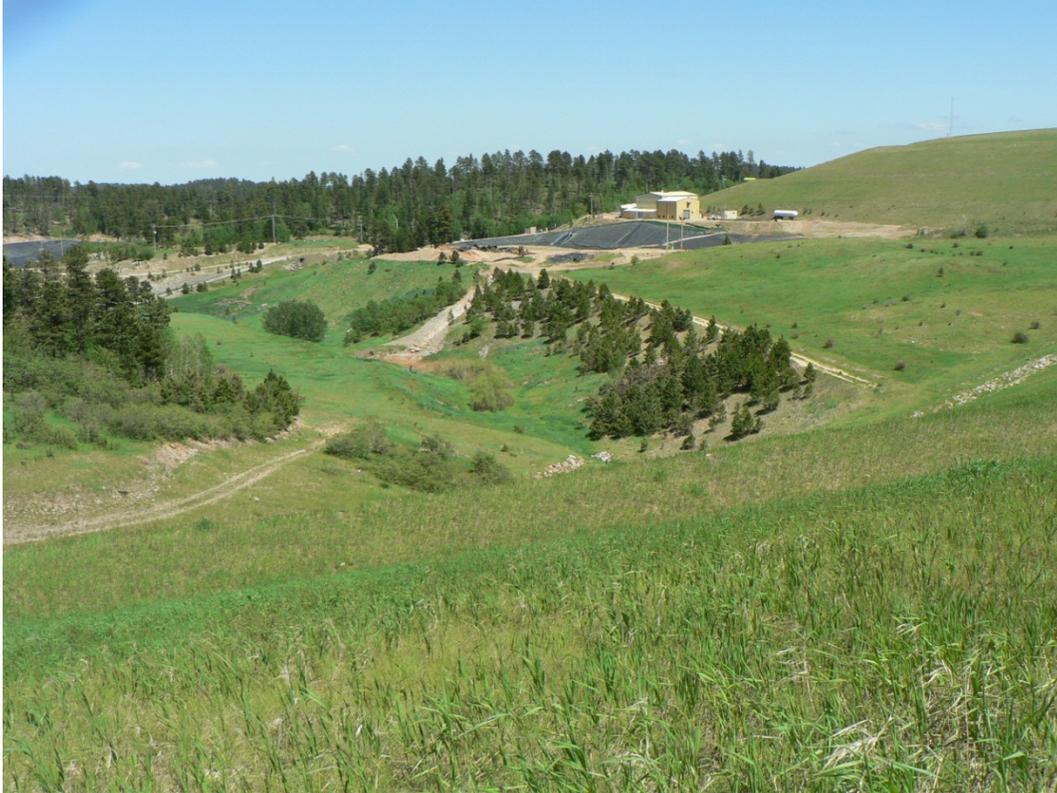
Limestone Quarry and Pad 3: The final stop on the field inspection was at the Limestone Quarry and the north corner of Pad 3 at 2:24 pm MDT. We did a very brief inspection of the Limestone Quarry. We then proceeded to the top of Pad 3. Vegetative cover on Pad 3 is in its sixteenth growing season and continues to be very good to excellent. No new erosion was noted. LAC established two vegetation transects on Pad 3 (Pad 3-2 and Pad 3-3) and collected data from 1998 through 2012. Live vegetative cover in the Pad 3-2 transect varied from a low of 33 percent in 1998 to a high of 67 percent in 2008 and averaged 57 percent over the 15 year monitoring period. Live vegetative cover in the Pad 3-3 transect varied from a low of 46 percent in 2002 to a high of 72 percent in 2011 and averaged 60 percent over the 15 year monitoring period. The overall average of 58 percent for the 15 year monitoring period exceeds the 40 percent cover standard established for the mine site.

Average vegetative cover was estimated at 55 percent which is close to the overall average and above the 40 percent cover standard. Grasses and legumes present that are part of the approved seed mix include kentucky bluegrass, smooth brome, western wheatgrass, hard fescue, white dutch clover, and blue flax. Other species present include black medic, assorted vetches, and moss. Noxious and other weeds present include tansy. LAC needs to continue to spray ceanothus on the pad.

Photo 9. Reclaimed areas below Pad 3. Process Plant and Pad 1 are in upper right of the photo.
