LAC MINERALS FINAL RECLAMATION INSPECTION PHOTOGRAPHS

Area: Spruce Gulch

Date: 8/18/10

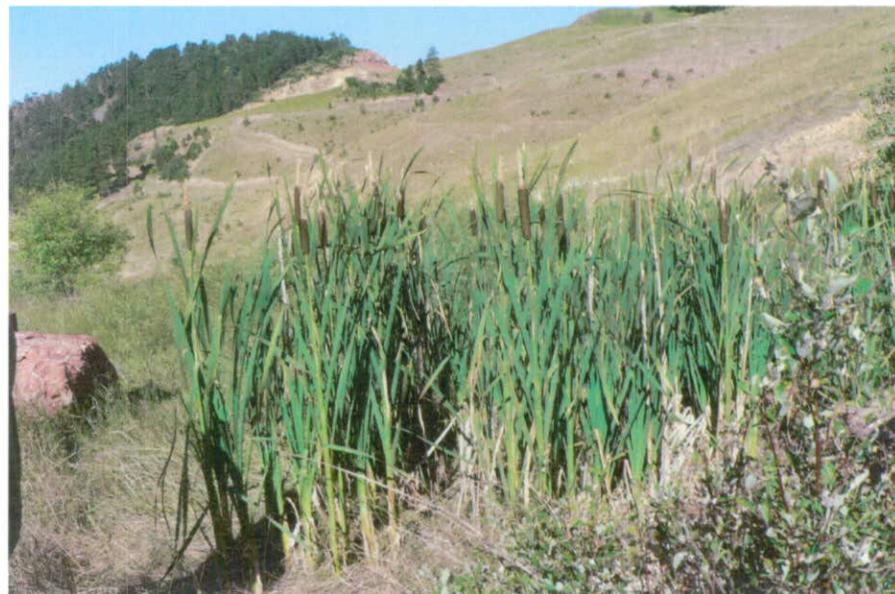
Photo SG-6 – Cattails in wetland area.

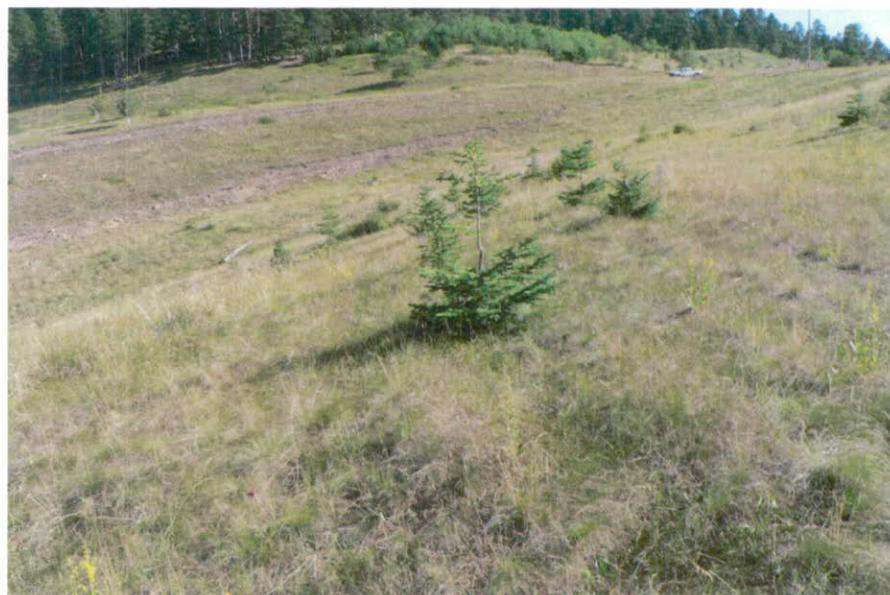
Photo SG-8 – Black Hills Spruce trees in Spruce Gulch.

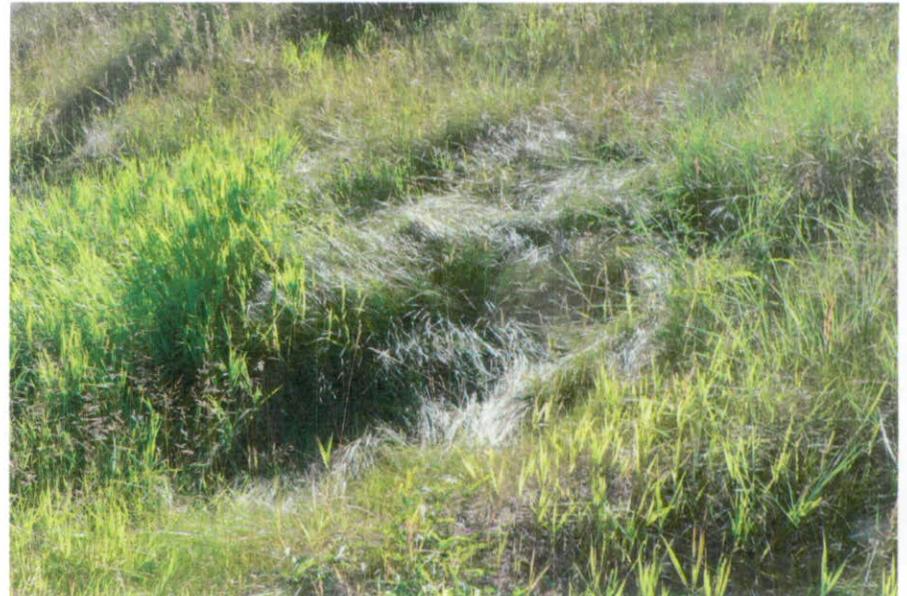
Photo SG-12 – Deer bedding area in Spruce Gulch.

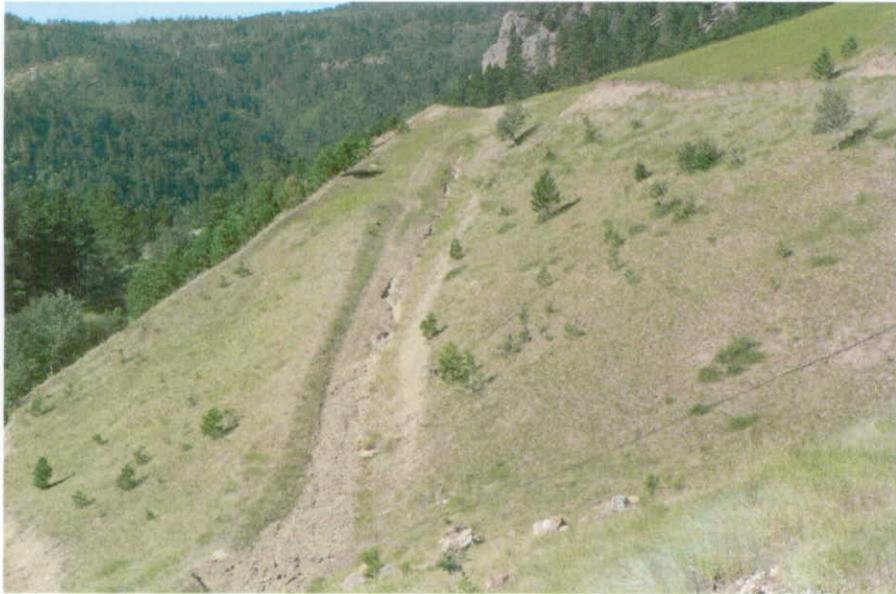
Photo SG-13 – Erosion along road in Spruce Gulch.

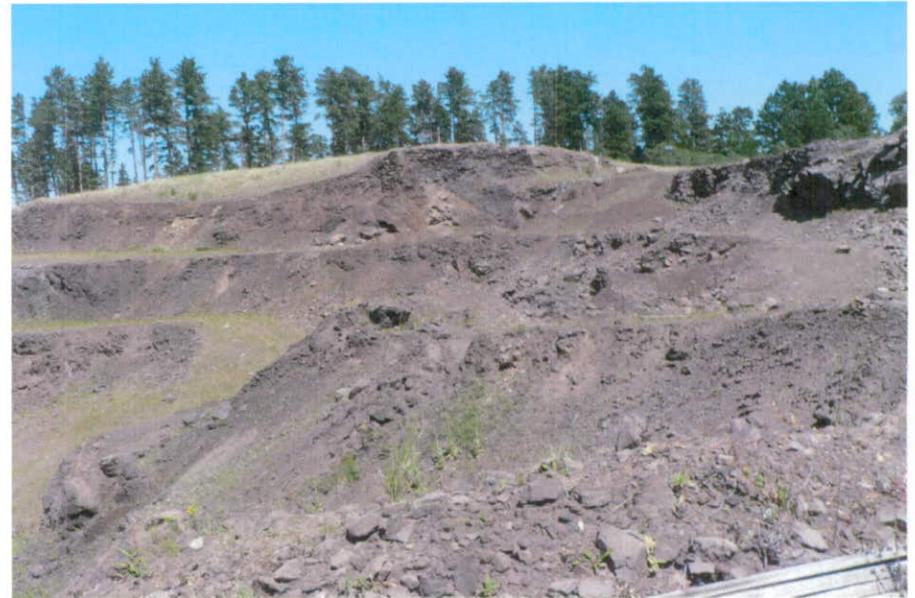
Photo LQ-2 – Fossil collection area.

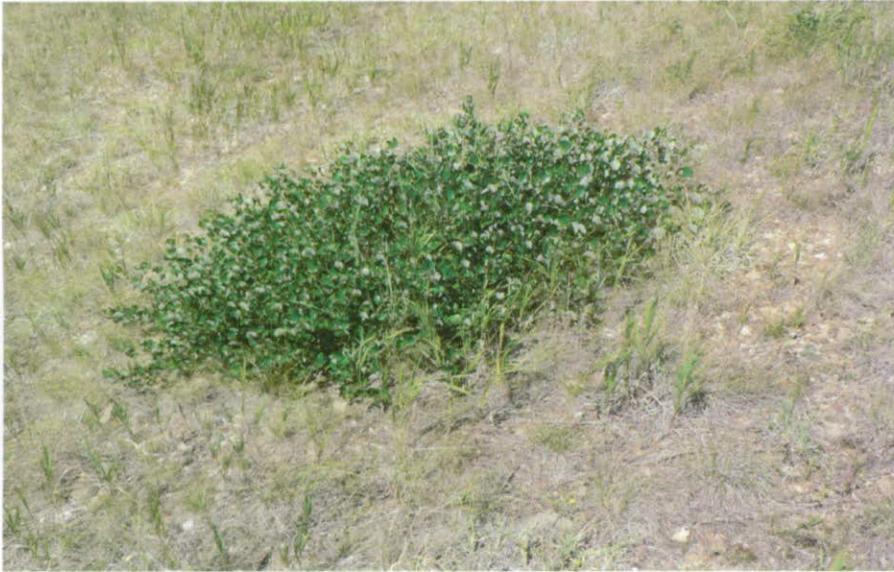
Photo LP3-5 – Volunteer ceanothus shrub on Leach Pad No. 3.

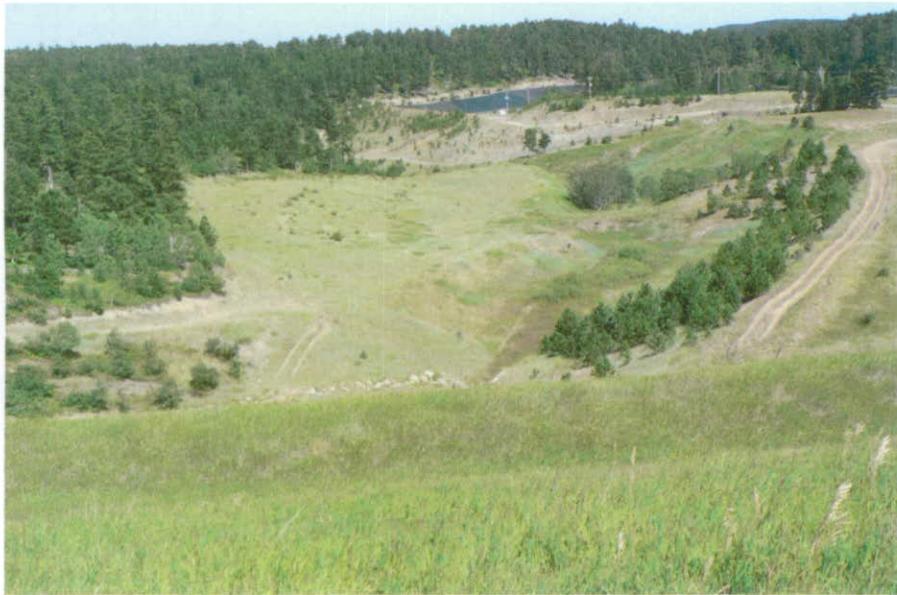
Photo LPC-1 – Leach Pad Corridor.

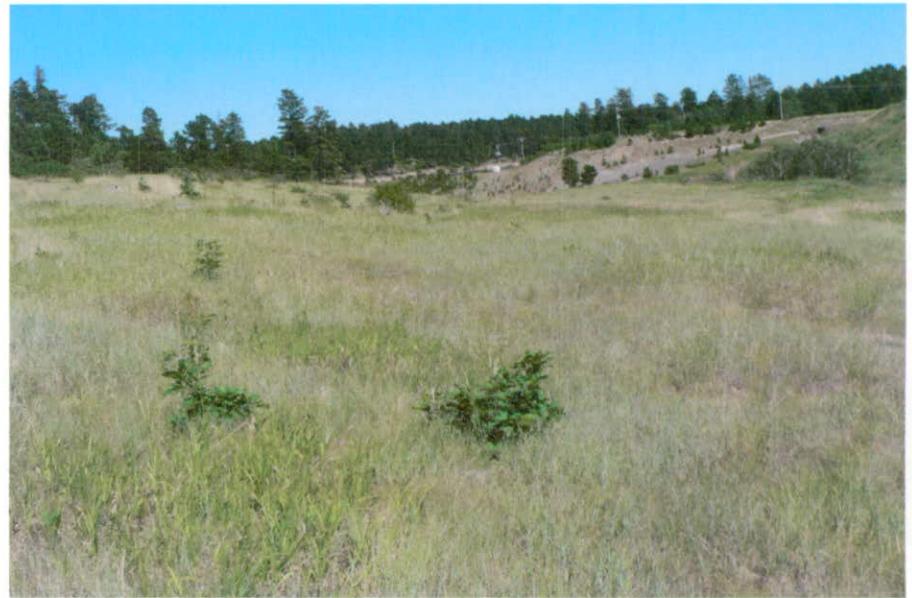
Photo LPC-2 – Vegetative cover in Leach Pad Corridor, looking northeast.

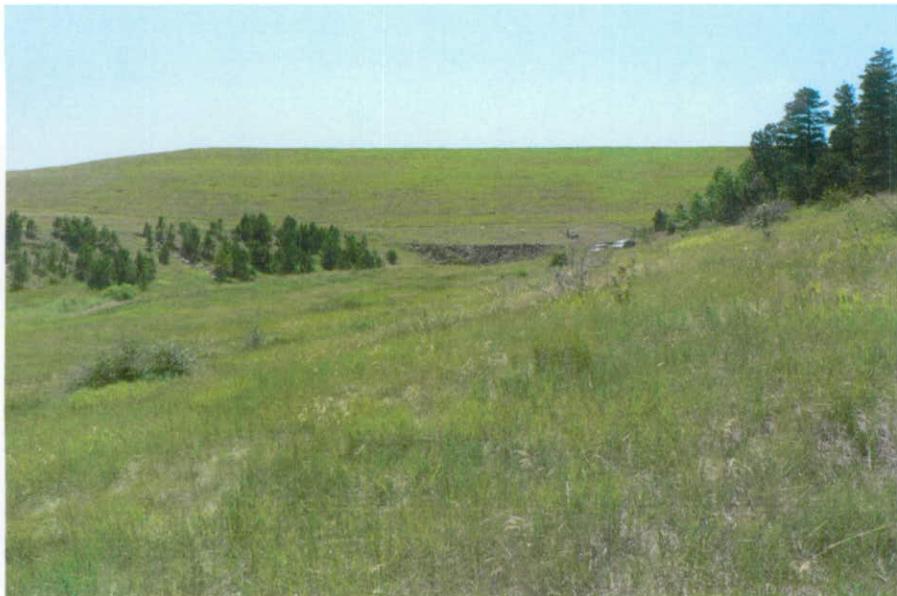
Photo LPC-3 – Vegetative cover in Leach Pad Corridor, looking southwest.

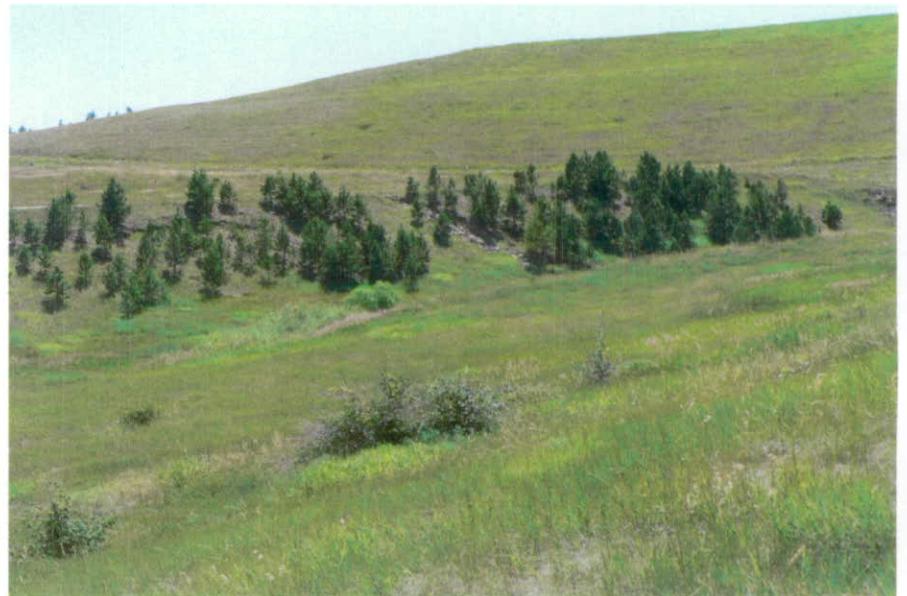
Photo LPC-4 – Pine trees and willows along drainage.

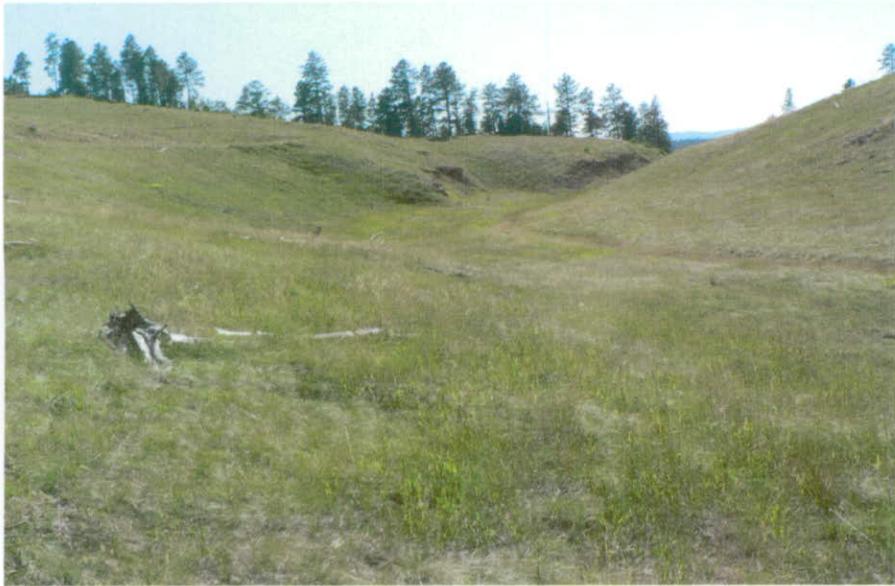
Photo VN-1 – V-Notch, looking west.

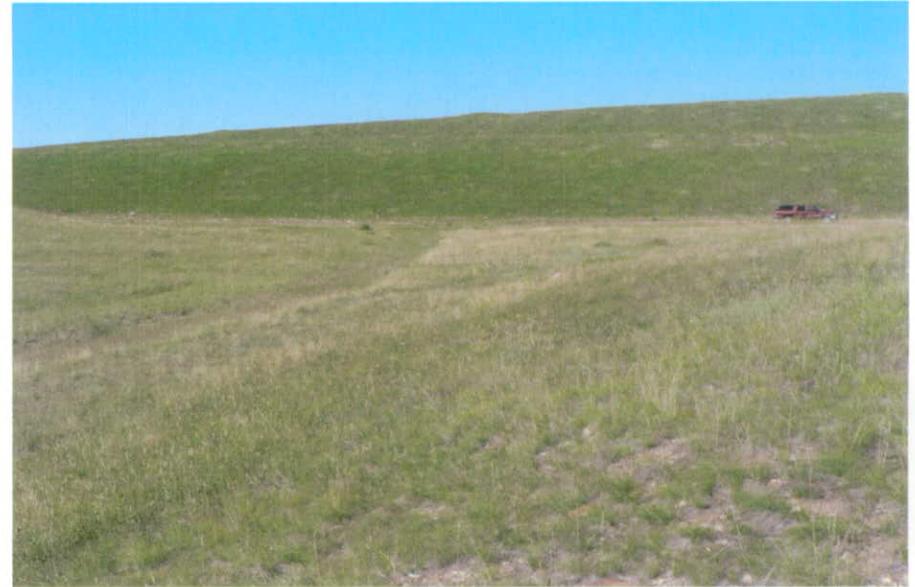
Photo VN-2 – Vegetative cover in V-Notch, looking east.

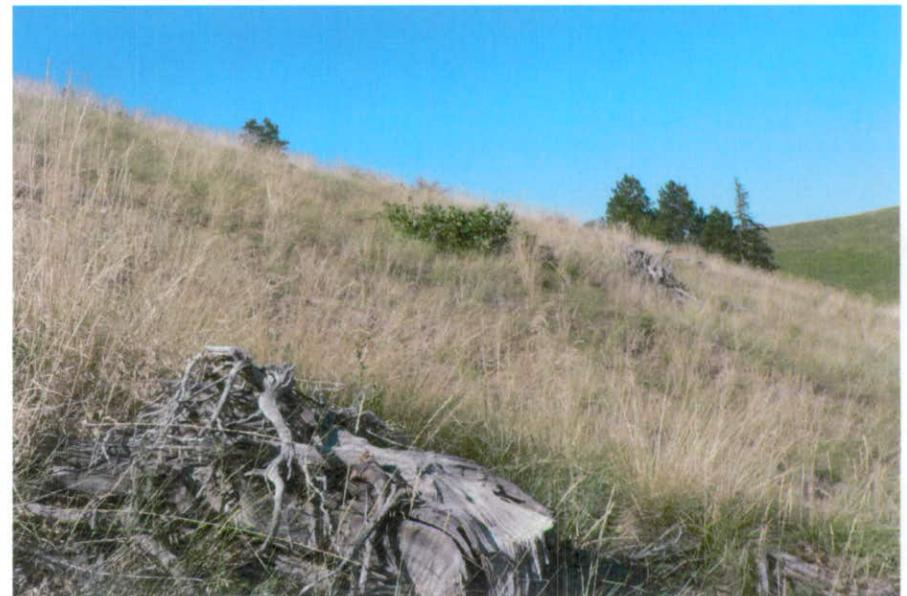
Photo VN-4 – Shrub on V-Notch slope.

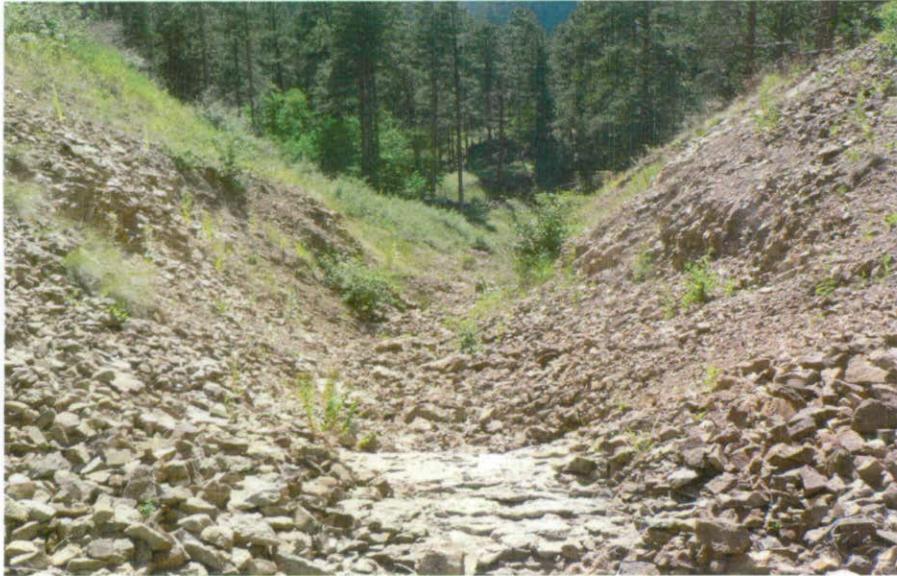
Photo VN-5 – V-Notch channel, looking west.

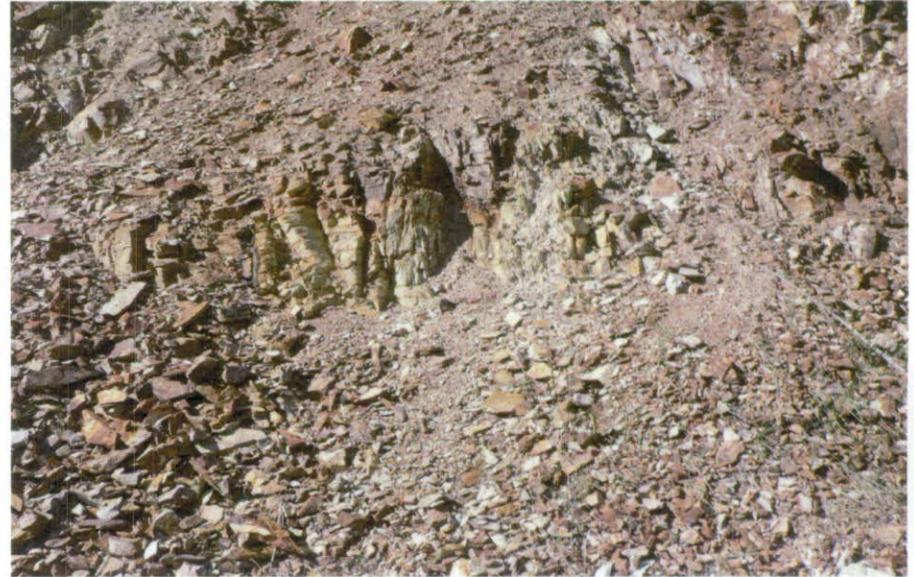
Photo VN-6 – Acid seep in channel.

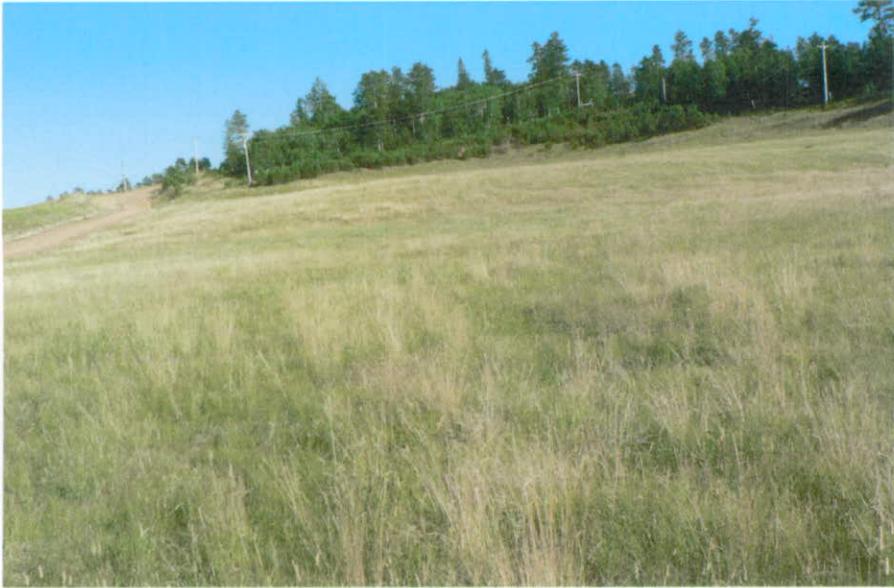
Photo CR-1 – Crusher area, looking east.

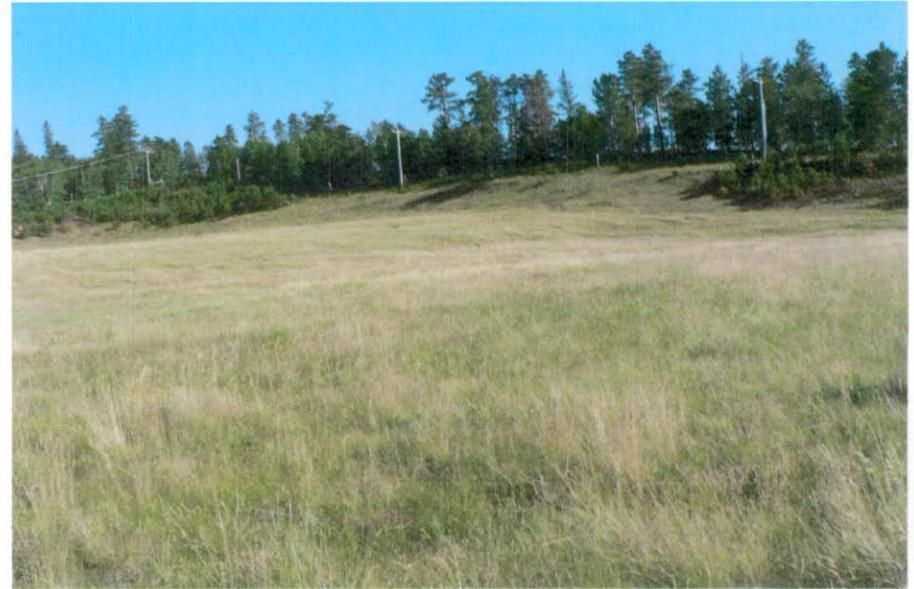
Photo CR-2 – Vegetative cover in Crusher area, looking southeast.

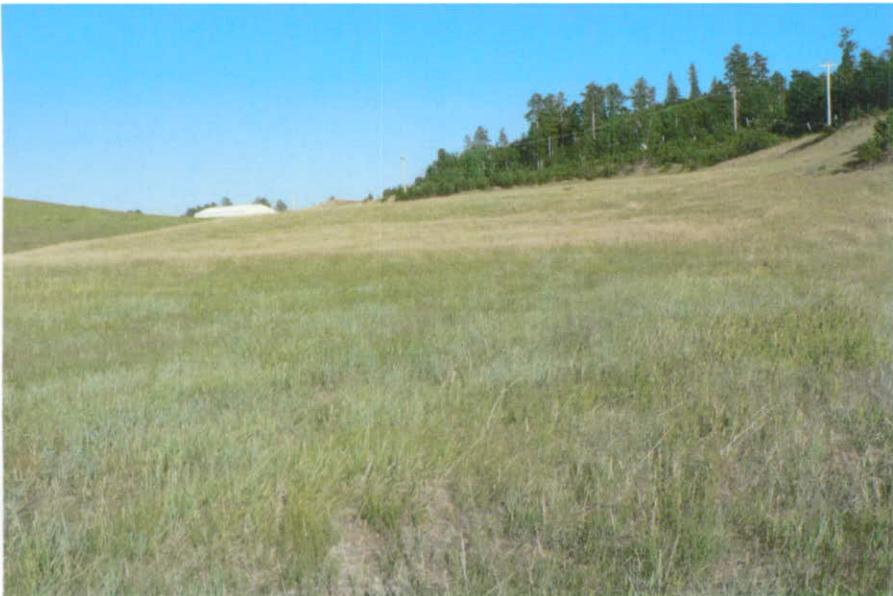
Photo CR-3 – Vegetative cover in Crusher area, looking northeast.

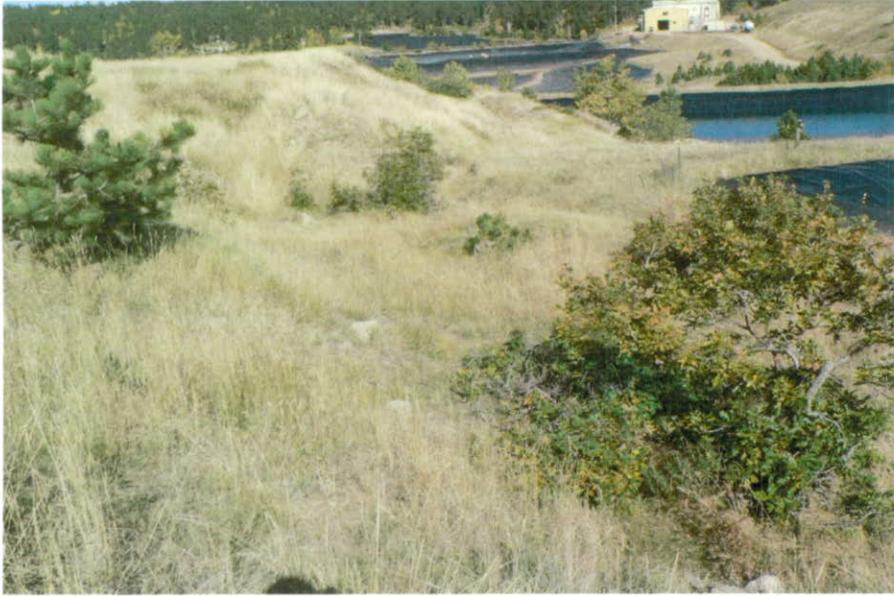
Photo LPC-1 –Leach Pad Corridor near discharge ponds.

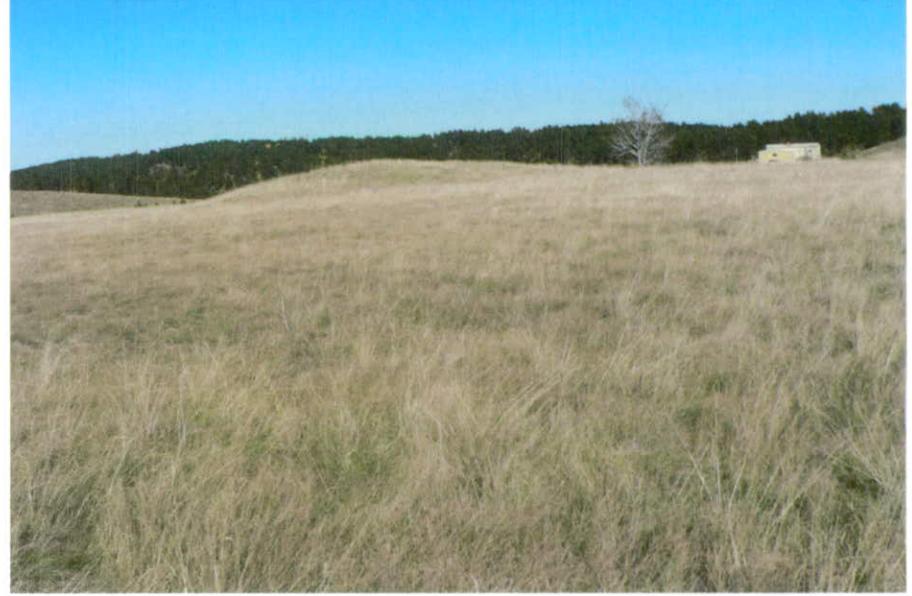
Photo LPC-2 – Vegetative cover on reclaimed area.

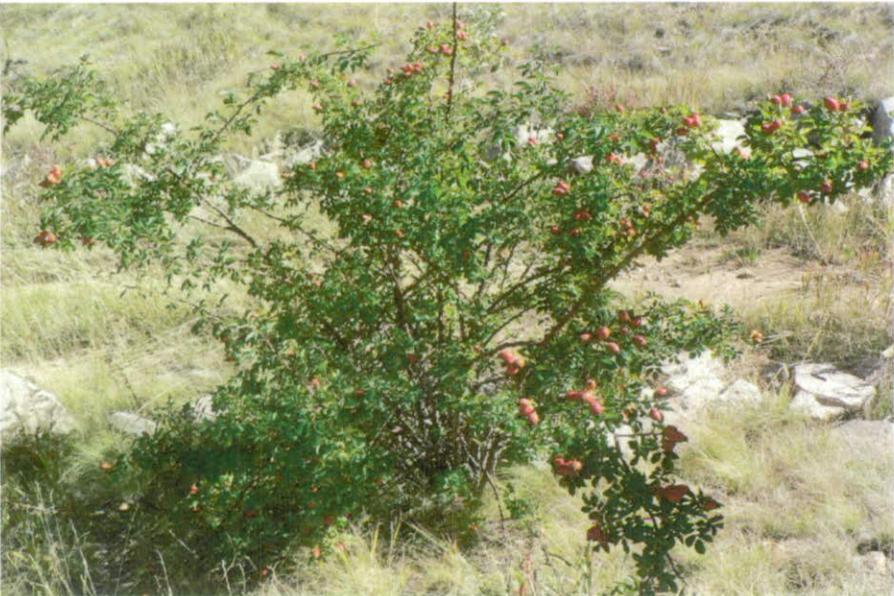
Photo LPC-3 – Rose hips on woods rose.

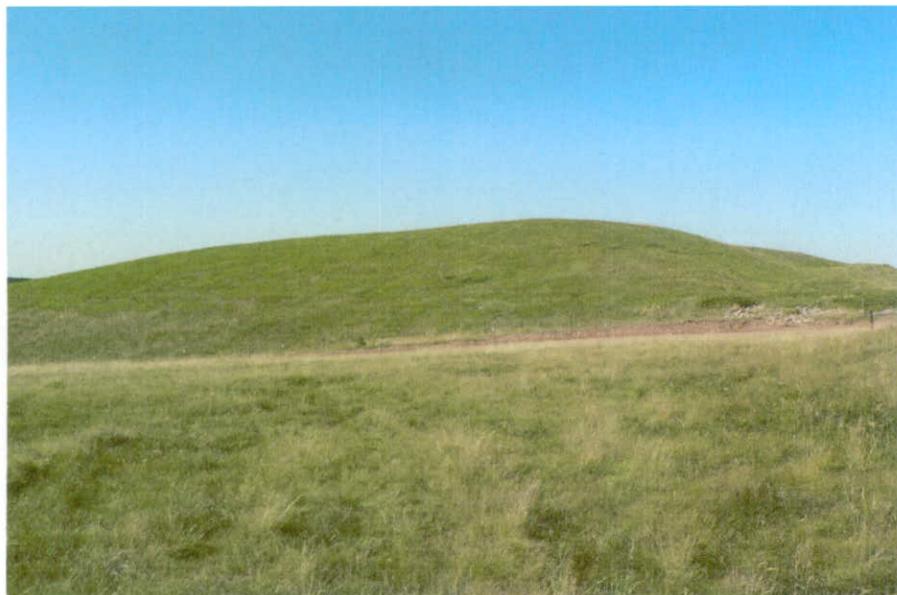
Photo LP12-1 – Leach Pad 1 and 2.

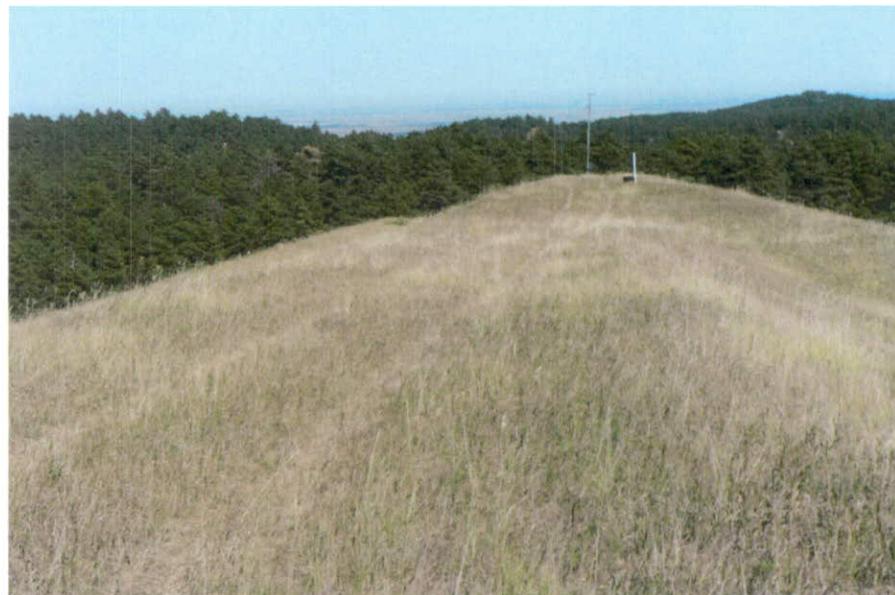
Photo LP12-2 – Radio tower in background.

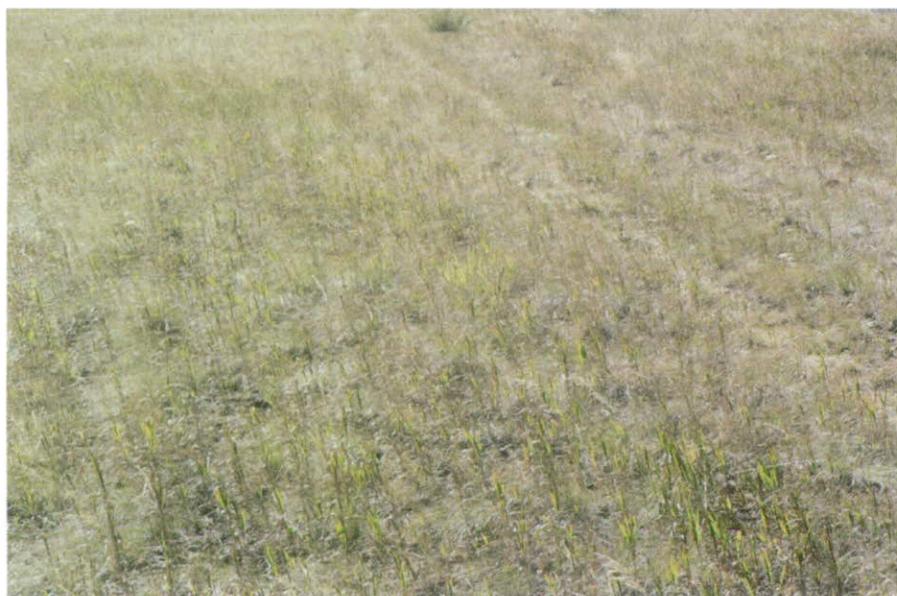
Photo LP12-3 – Vegetative cover on top of Leach Pad 1 and 2.

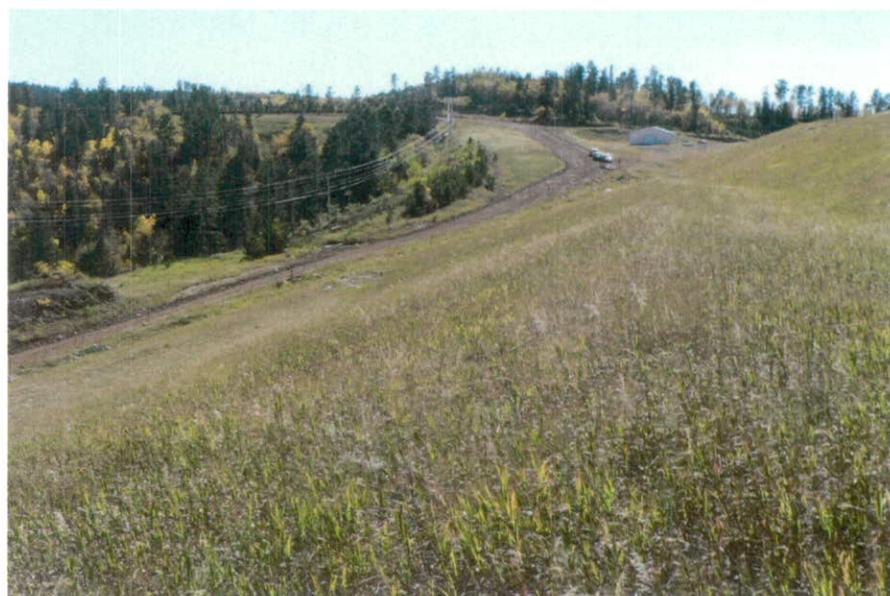
Photo LP12-4 – Vegetative cover on side slope of Leach Pad 1 and 2.

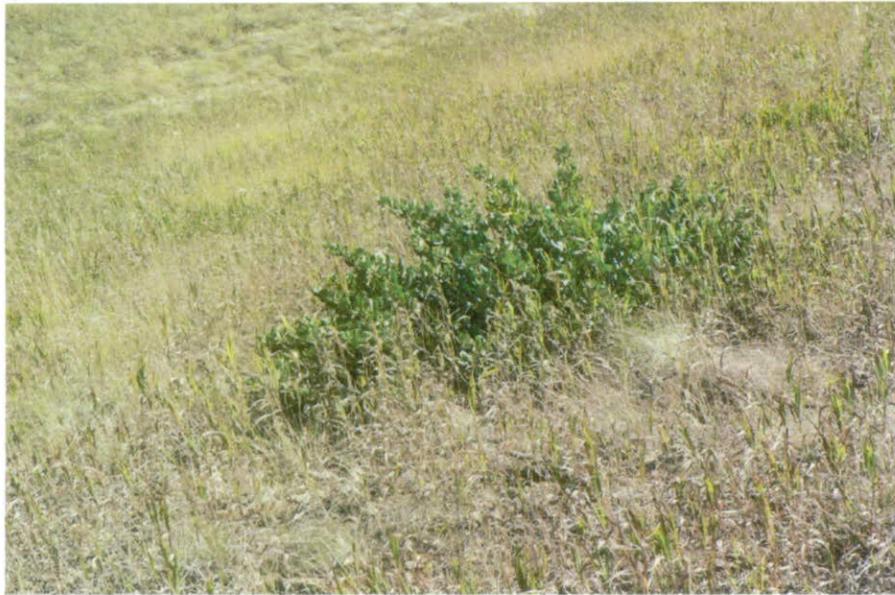
Photo LP12-5 – Ceanothus on Leach Pad 1 and 2.

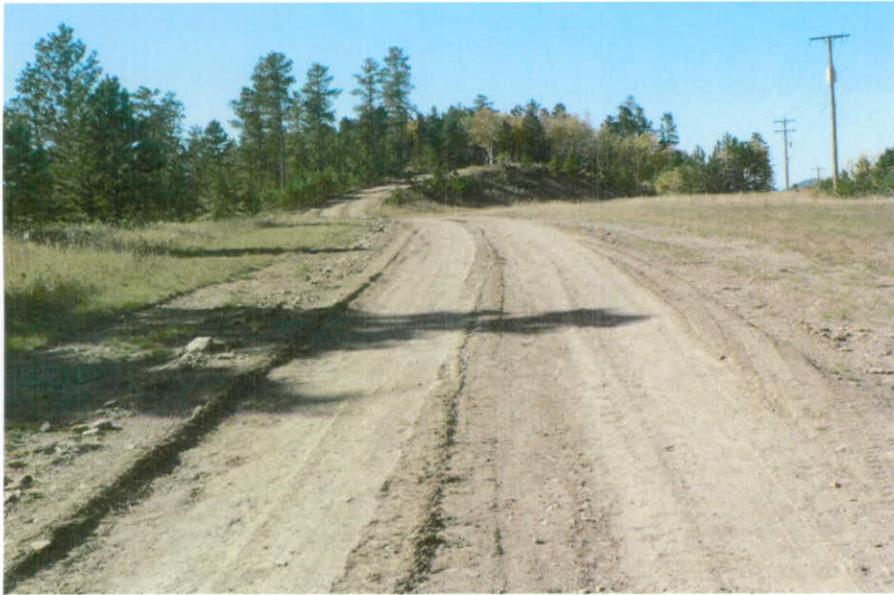
Photo ADM-1 – Old access trail.

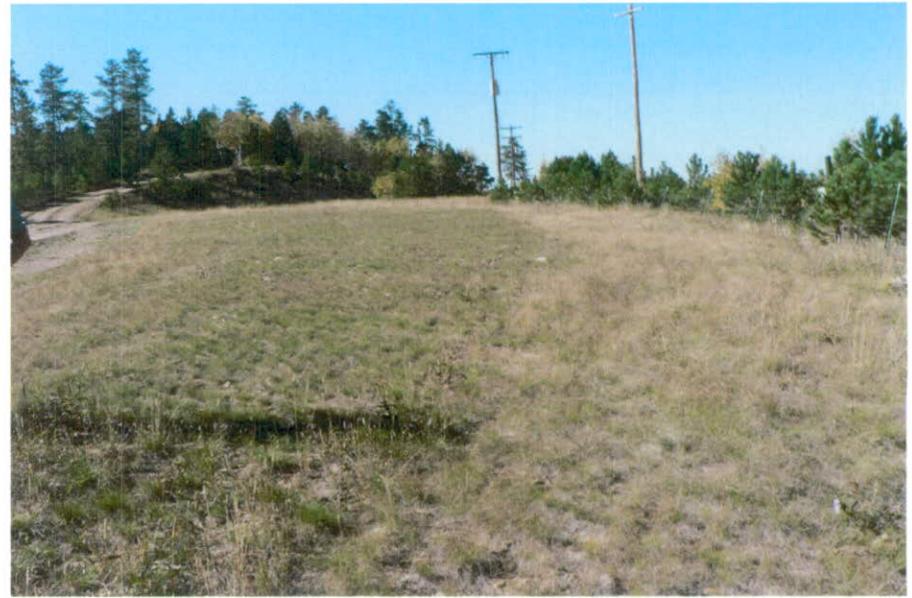
PhotoADM-2 – Vegetative cover on reclaimed area.

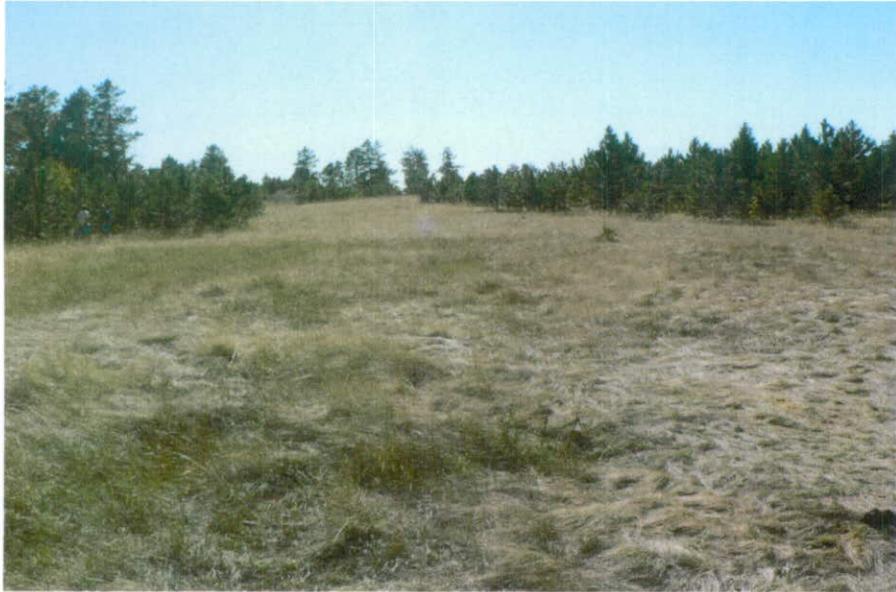
Photo TA-1 – Turnaround Pit.

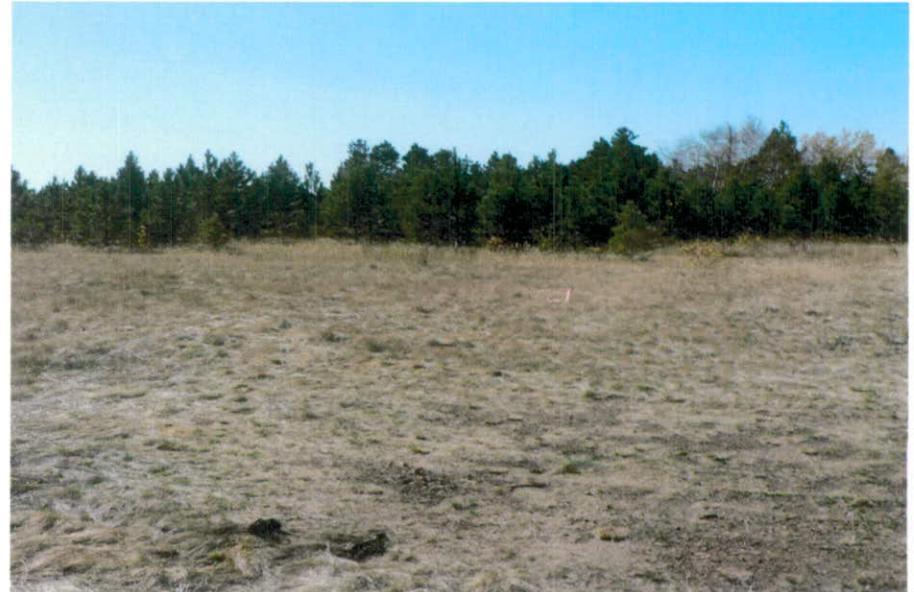
Photo TA-2 – Vegetative cover on reclaimed area, with pine trees in background.

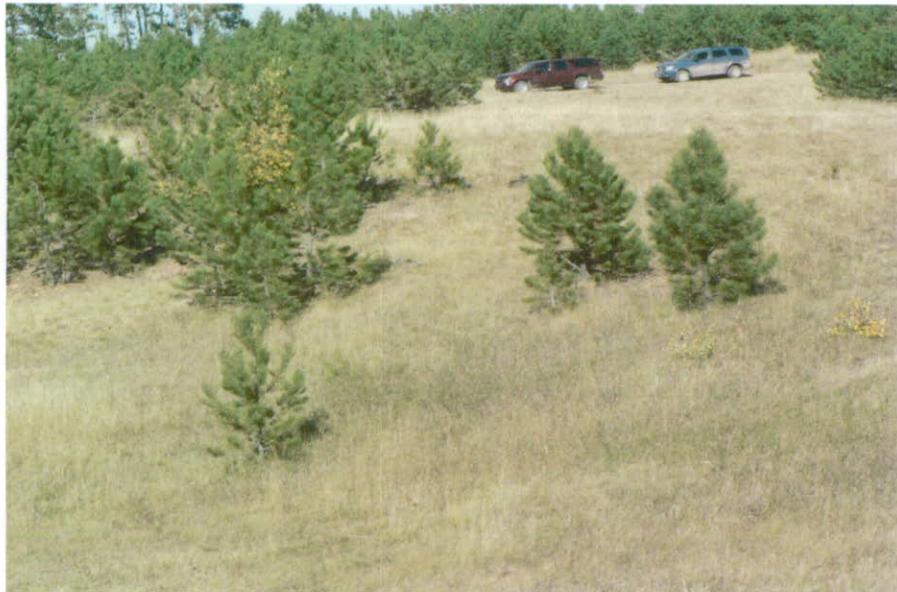
Photo TA-3 – Mixed pine forest.

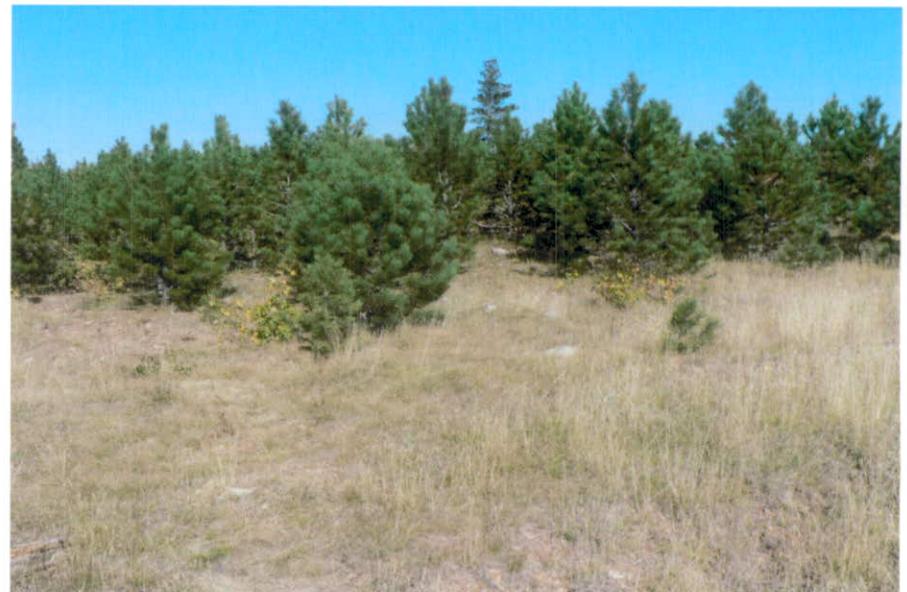
Photo TA-4 – Mixed pine forest.

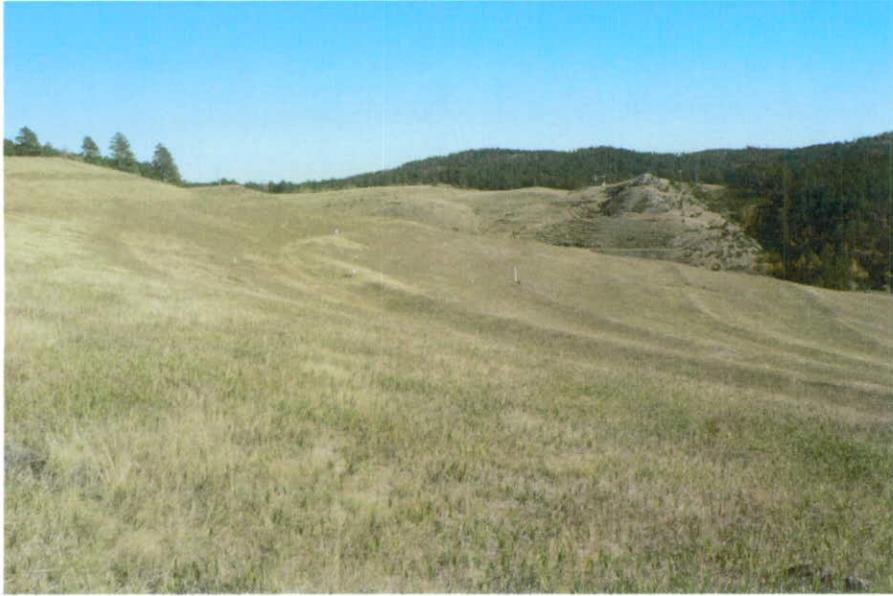
Photo PI-1 – Pit Impoundment.

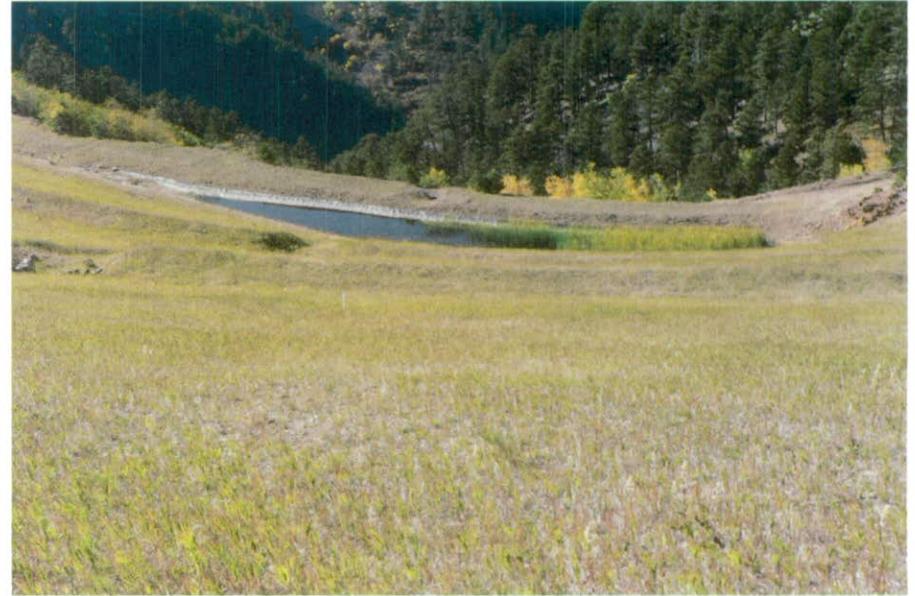
PhotoLPI-2 – Lined pond on west end of Pit Impoundment.

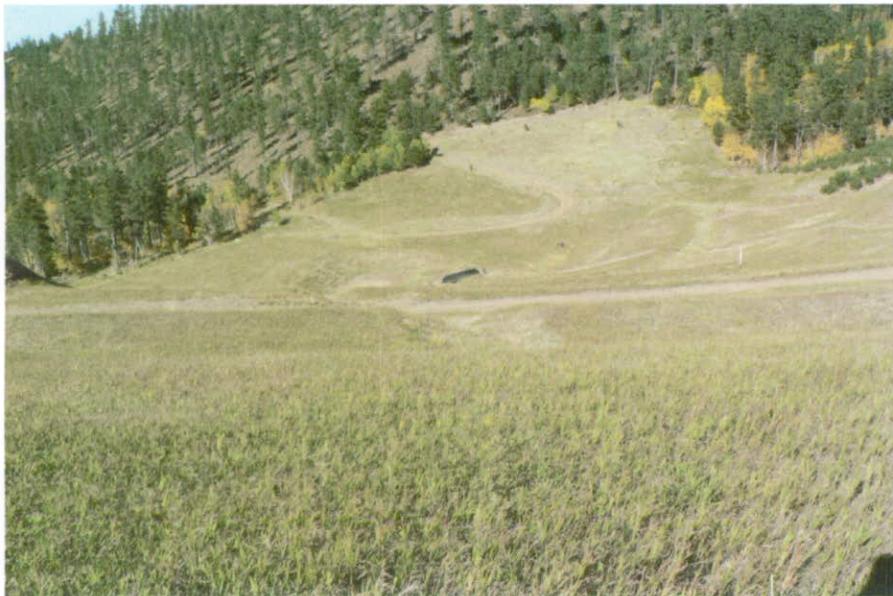
Photo PI-3 – Vegetative cover on Pit Impoundment, looking northwest.

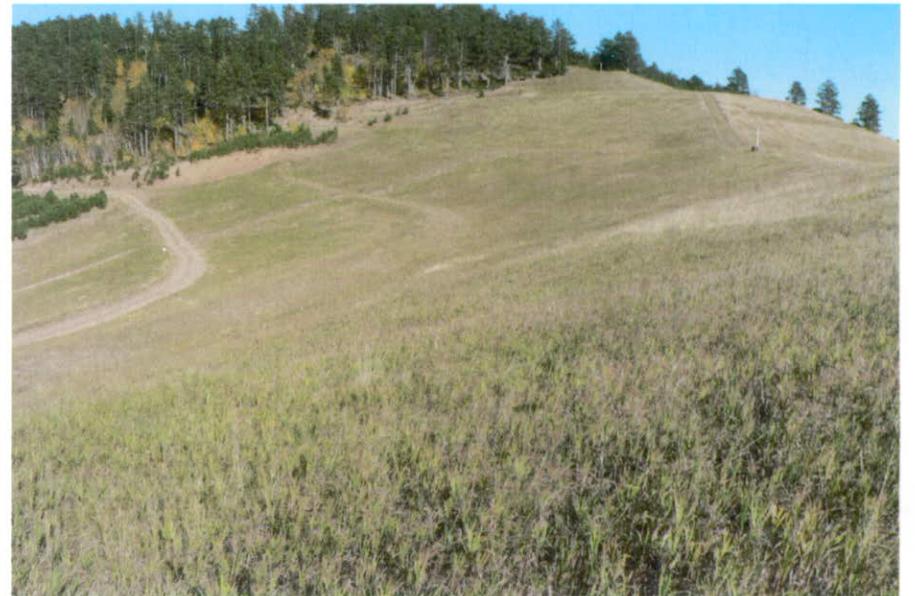
Photo PI-4 – Vegetative cover on Pit Impoundment, looking north.

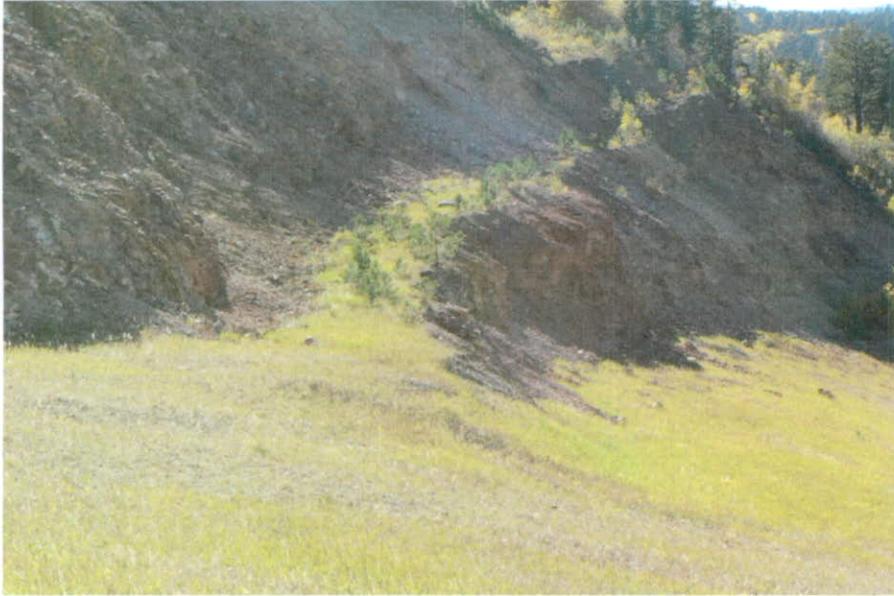
Photo PI-5 – Pine trees on old pit bench.

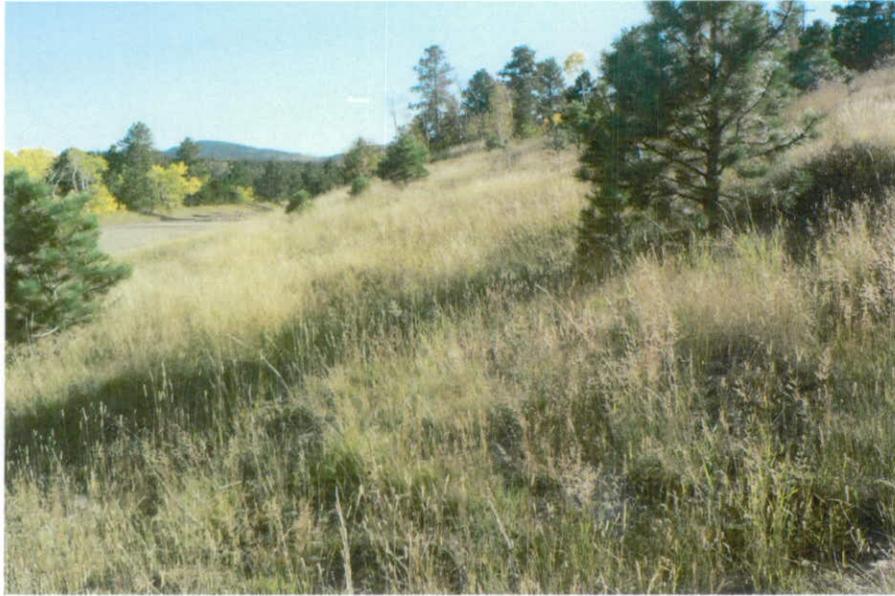
Photo HR-1 – Reclaimed topsoil stockpile, looking south.

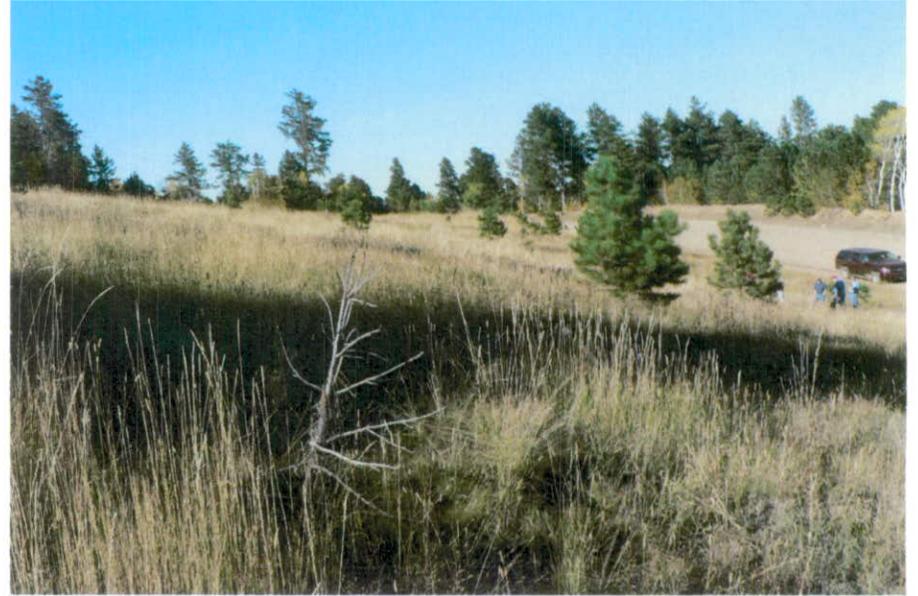
Photo HR-2 – Reclaimed topsoil stockpile, looking north.

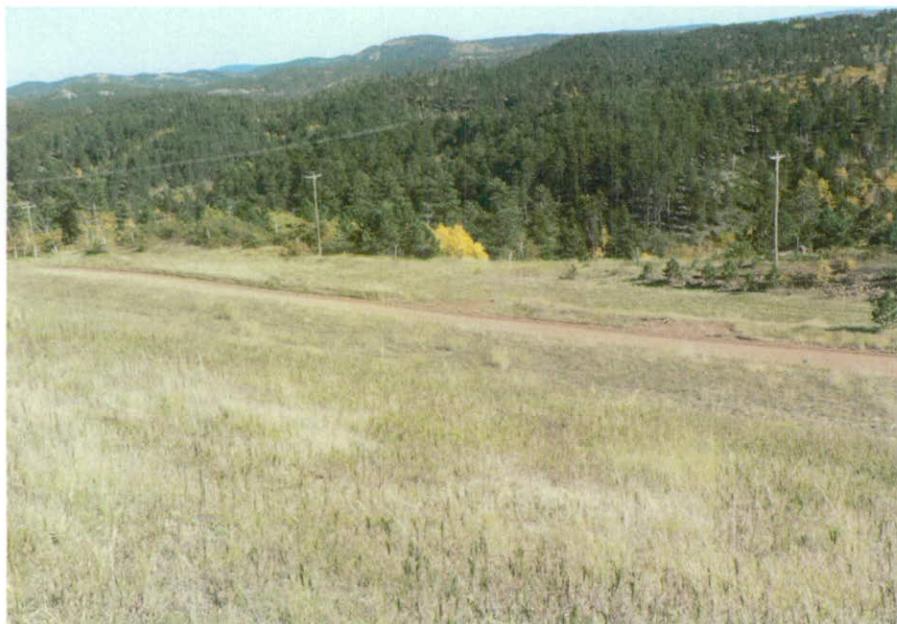
Photo AR-3 – Spearfish Fire Trail in middle of photo.

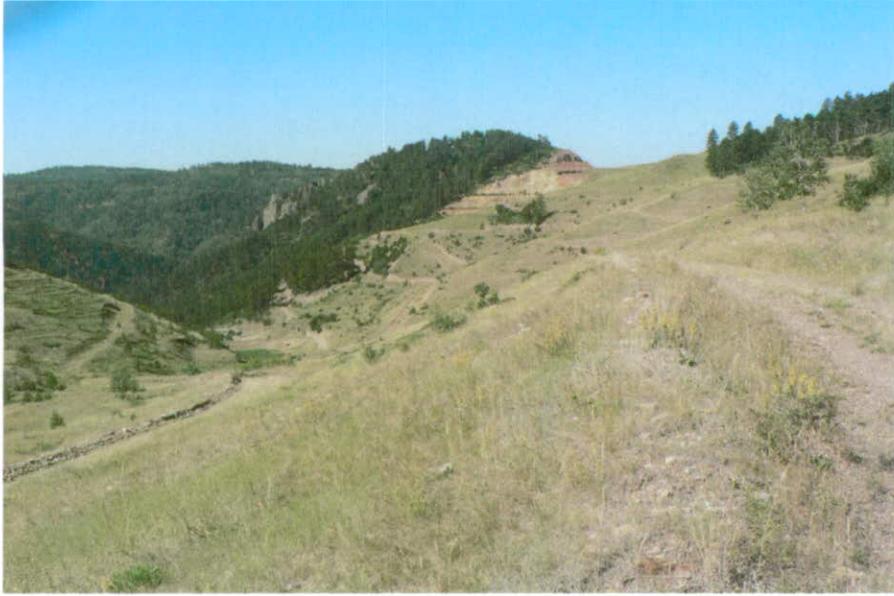
Photo SG-1 – View of Spruce Gulch, looking west.

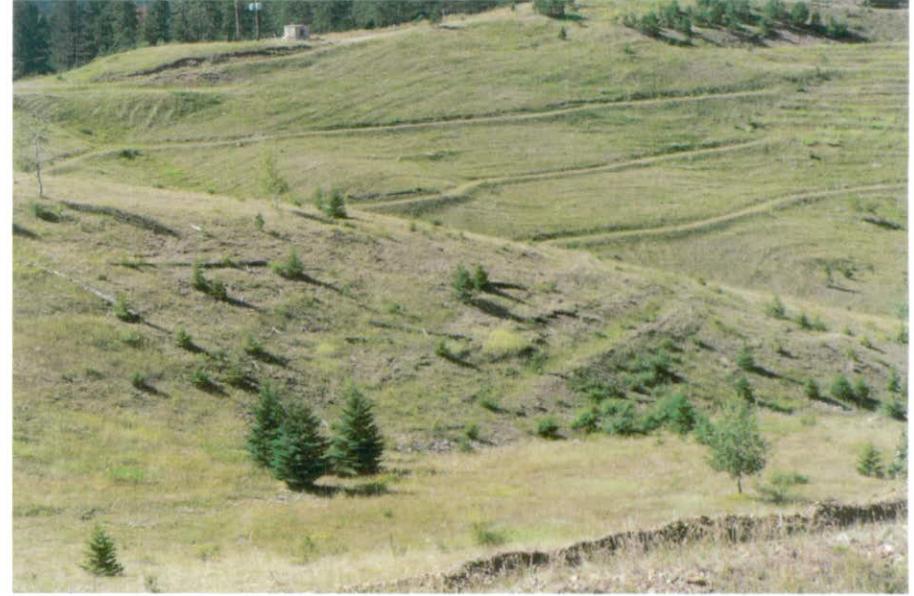
Photo SG-2 – Spruce Gulch, looking south.
