LAC MINERALS FINAL RECLAMATION INSPECTION PHOTOGRAPHS

Area: Spruce Gulch

Date: 8/18/10

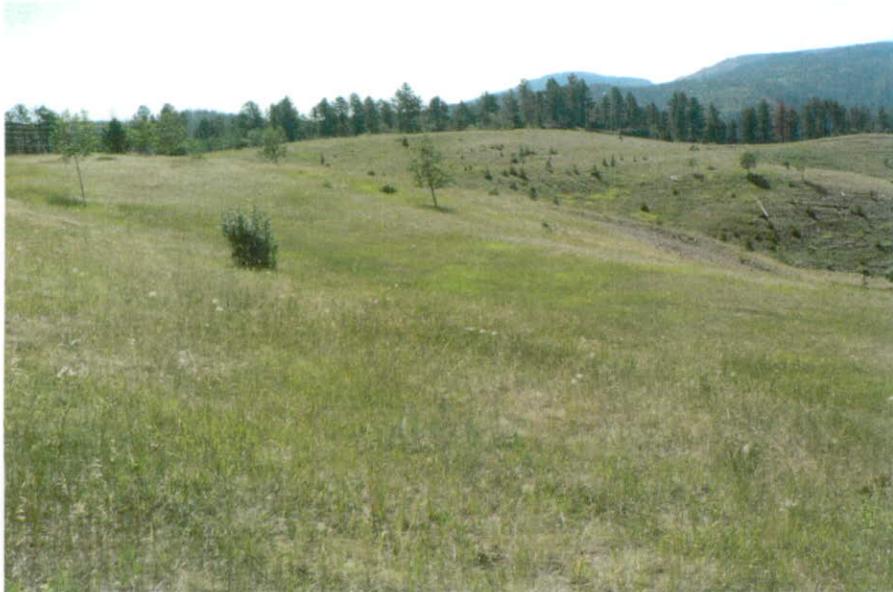
Photo SG-3 – Spruce Gulch, looking northeast

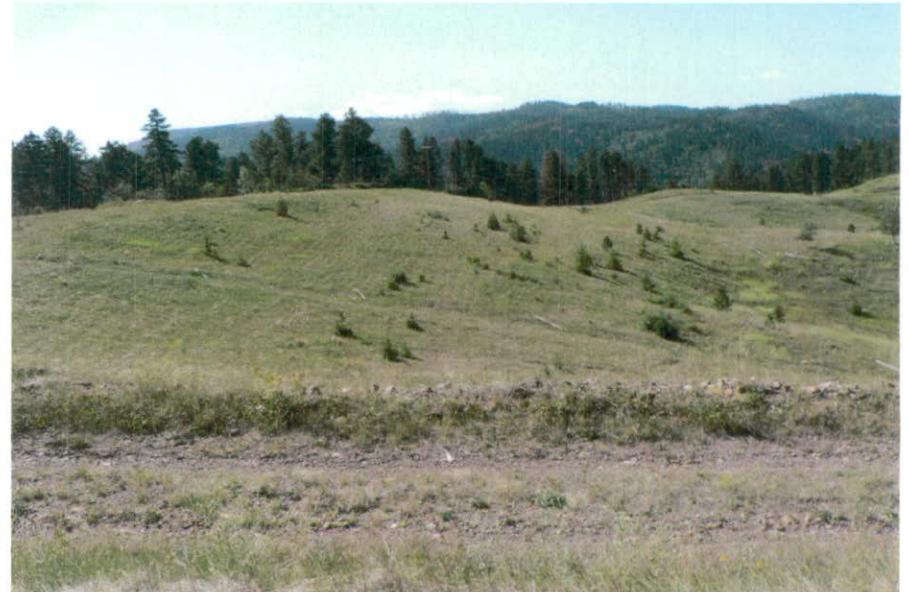
Photo SG-4 – Spruce Gulch, looking south.

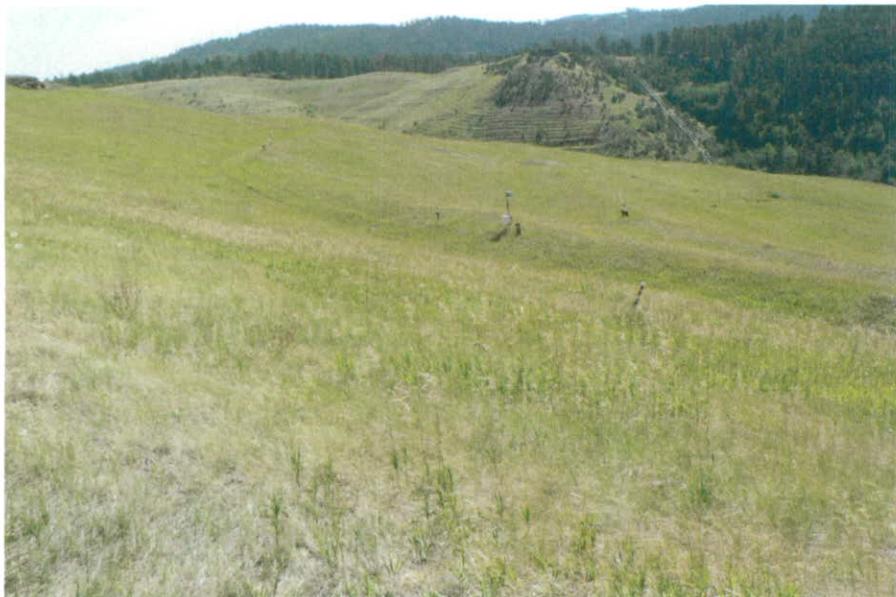
Photo PI-1 – View of Pit Impoundment, looking southeast.

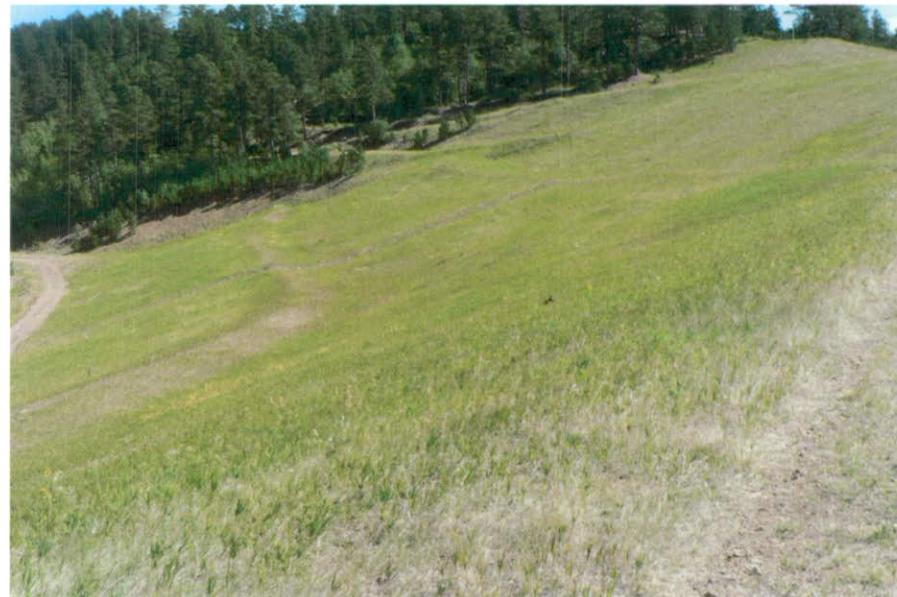
Photo PI-2 – Pit Impoundment, looking east.

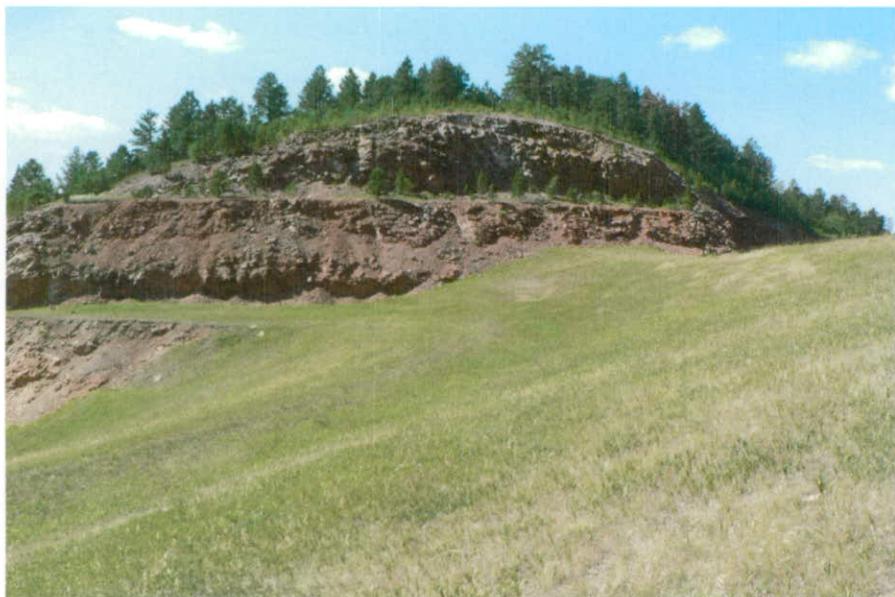
Photo PI-3 – Pit Impoundment, looking west. Pit highwall in background.

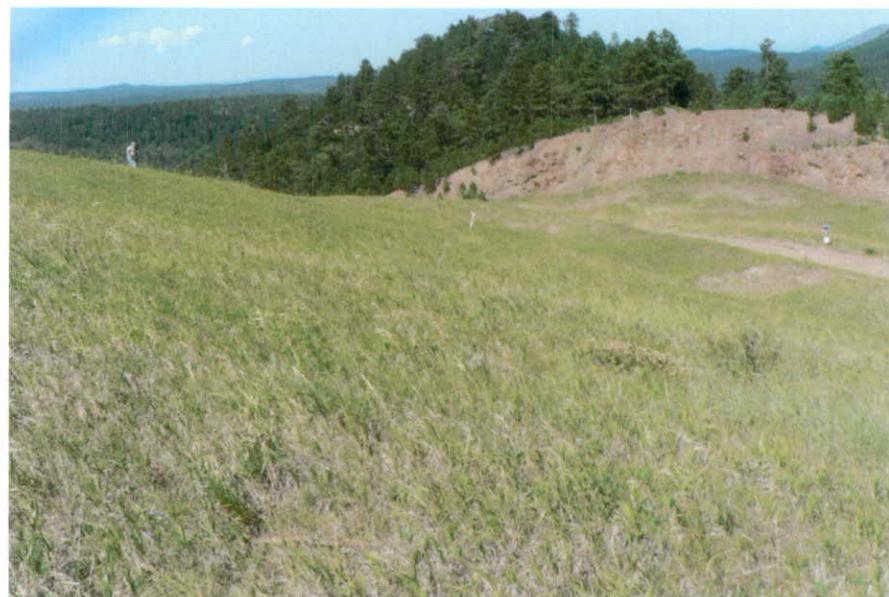
Photo PI-4 – Pit Impoundment, looking north. Pit highwall in background.

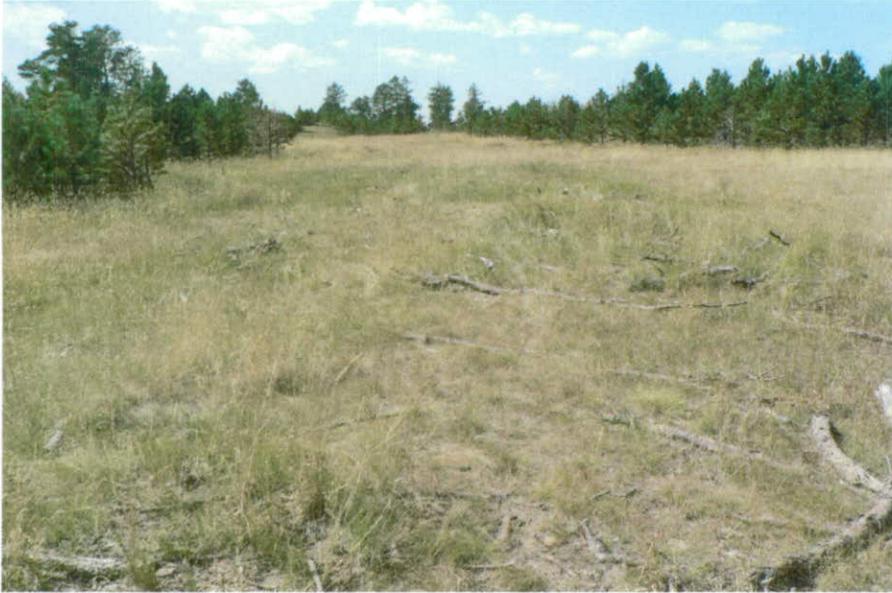
Photo TA-1 – View of Turnaround Pit, looking southeast.

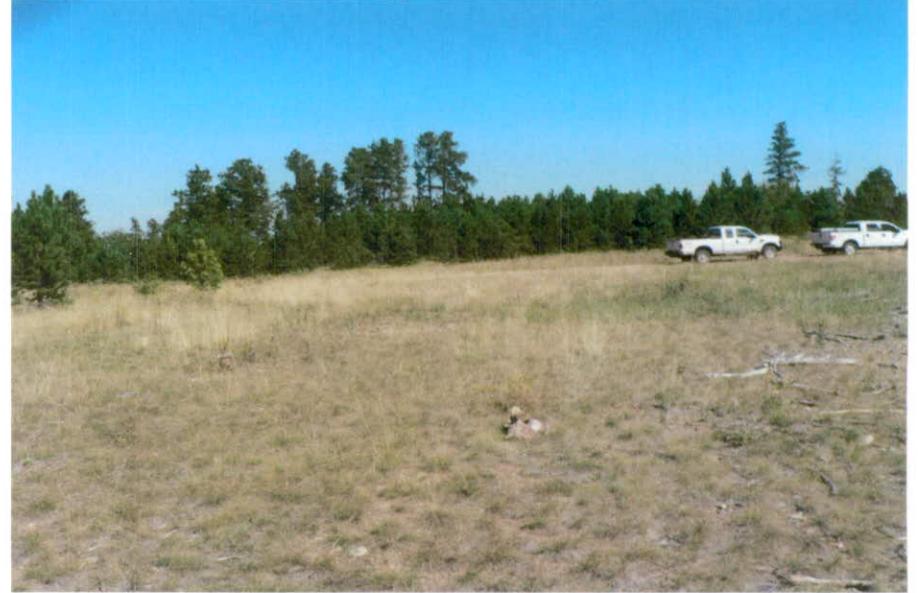
Photo TA-2 – Turnaround Pit, looking west.

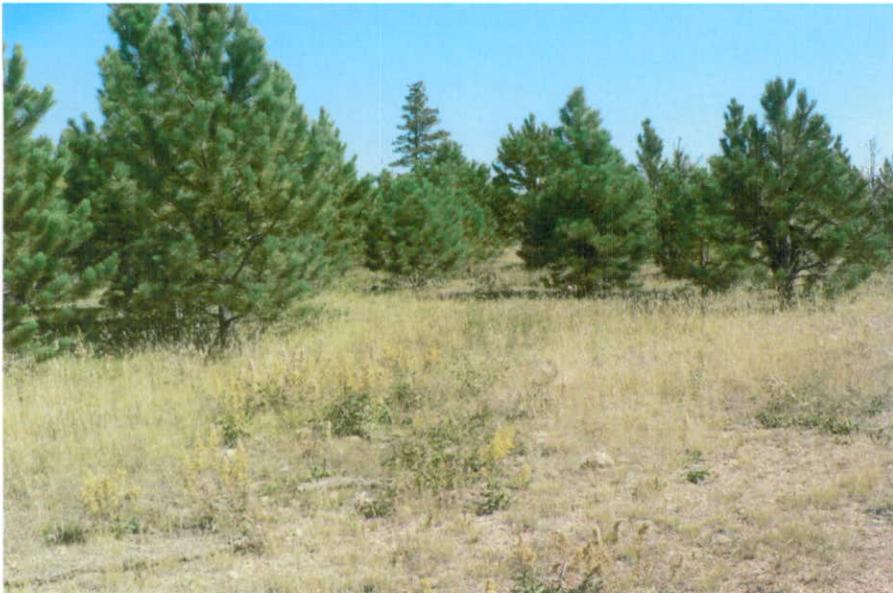
Photo TA-3 – Mixed pine forest in Turnaround area.

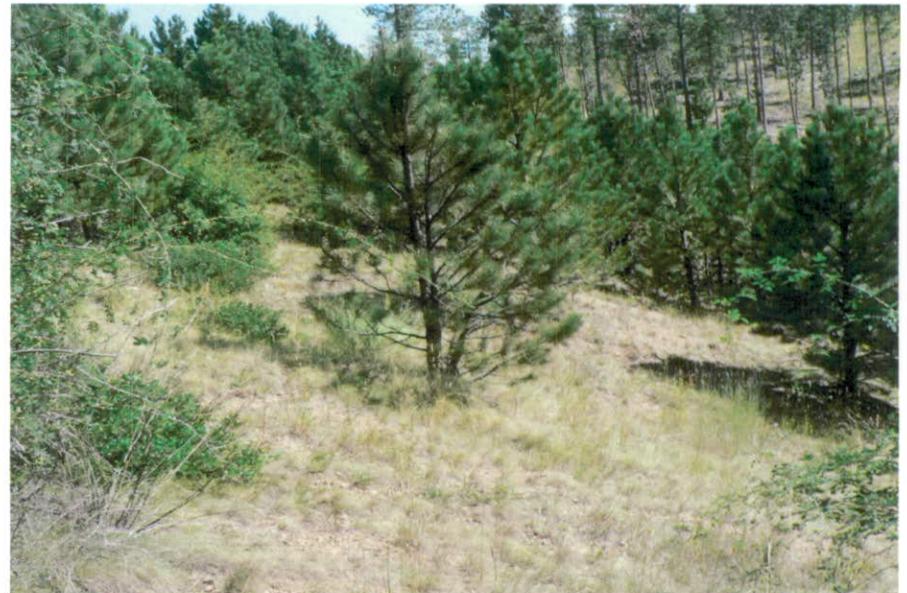
Photo TA-4 – Mixed pine forest in Turnaround area.

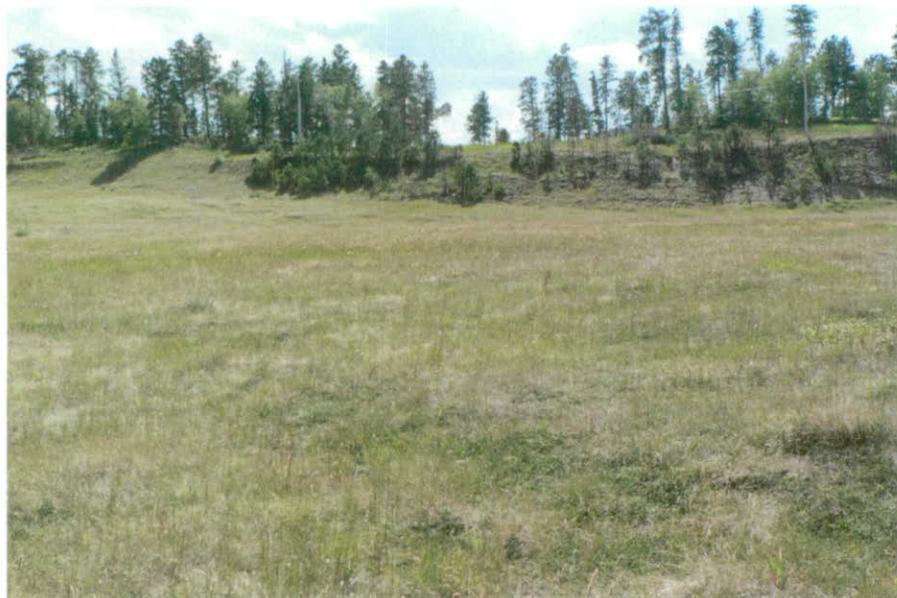
Photo CR-1 – View of Crusher area, looking southeast.

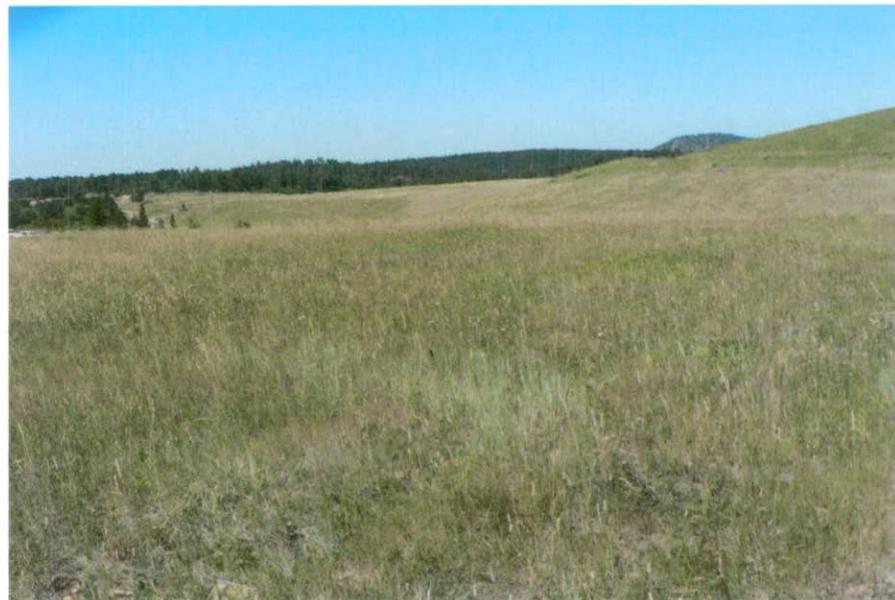
Photo CR-2 – Crusher area, looking northeast.

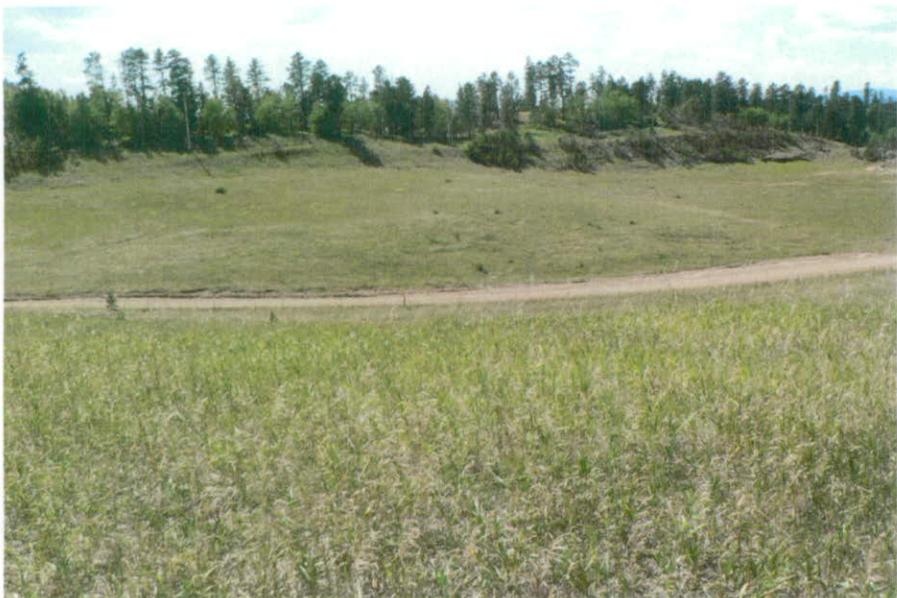
Photo CR-3 – View of Crusher area from Leach Pad 1 and 2.

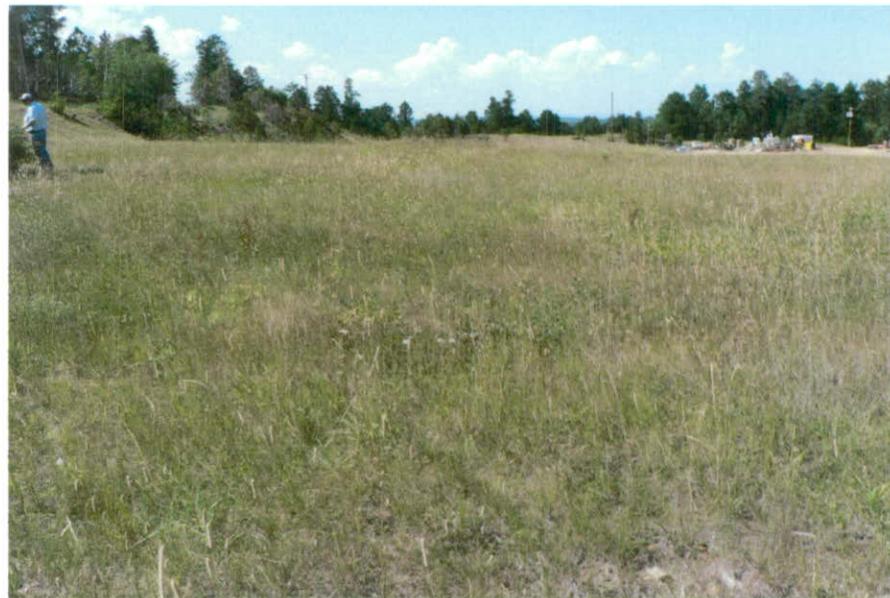
Photo CR-4 – Crusher area, looking west.

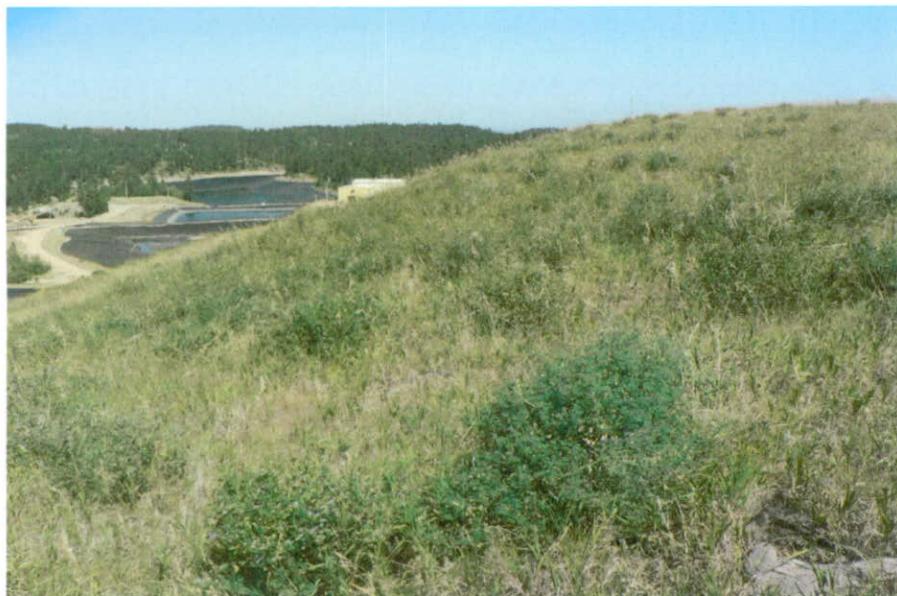
Photo LP12-1 – Top of Leach Pad 1 and 2, looking northeast.

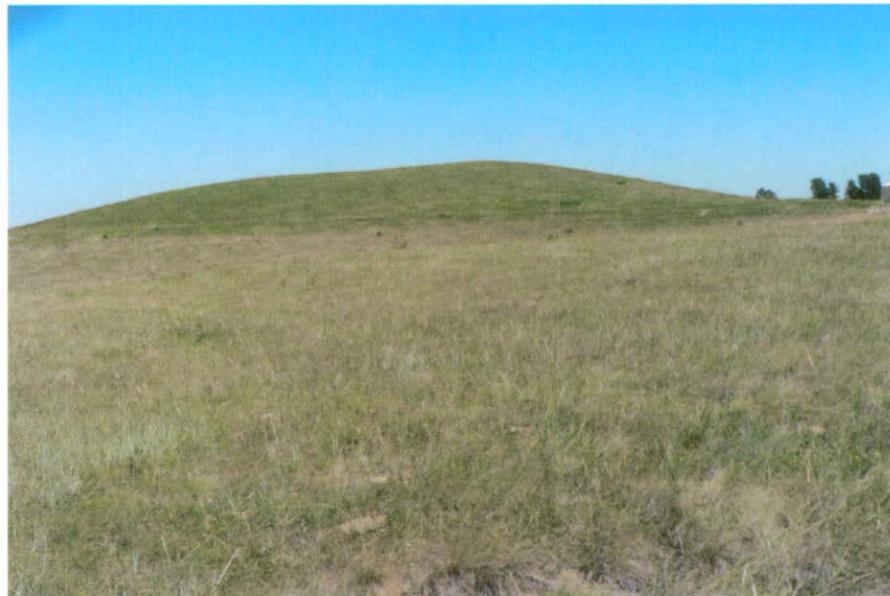
Photo LP12-2 – View of Leach Pad 1 and 2 from Crusher area.

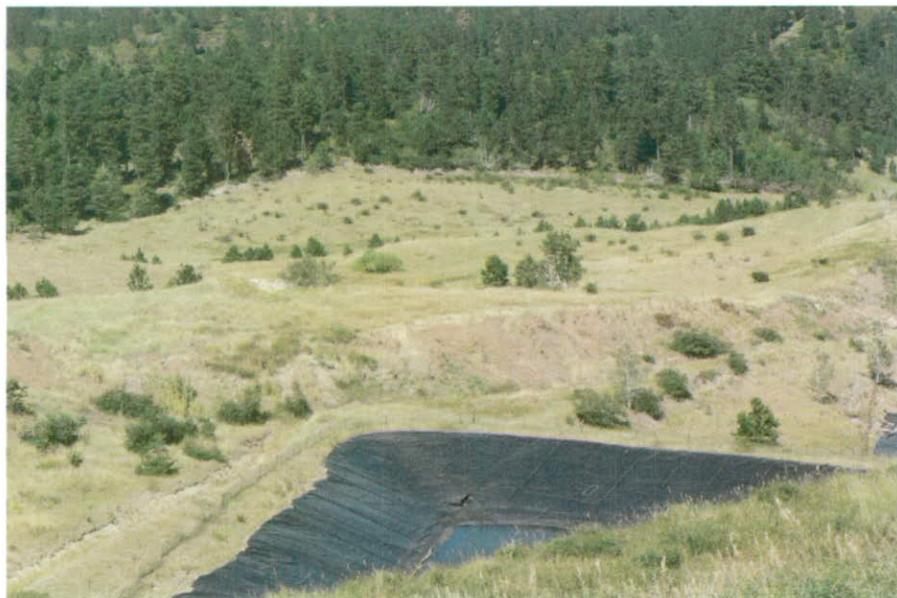
Photo LPC-1 – View of Leach Pad Corridor from top of Leach Pad 1 and 2.

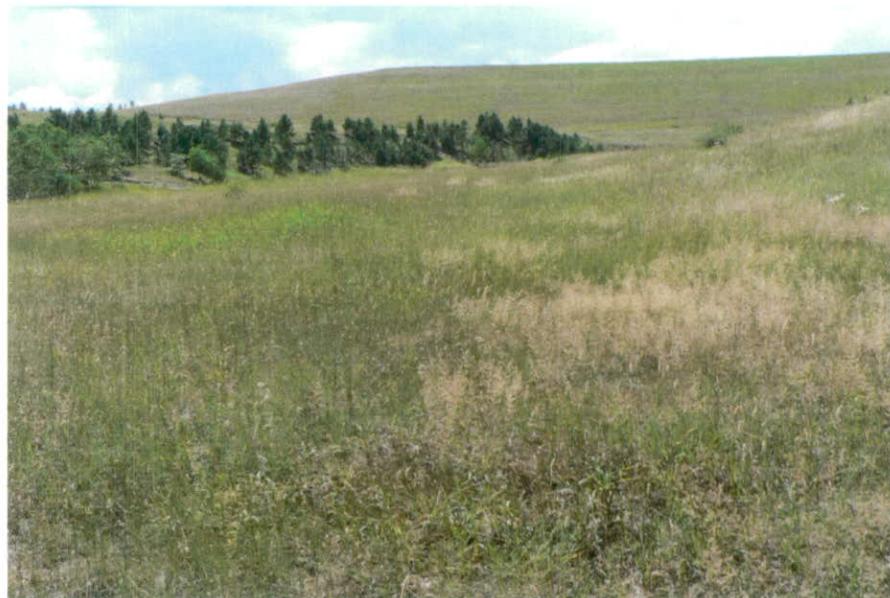
Photo LPC-2 – Leach Pad Corridor, looking toward Leach Pad 1 and 2.

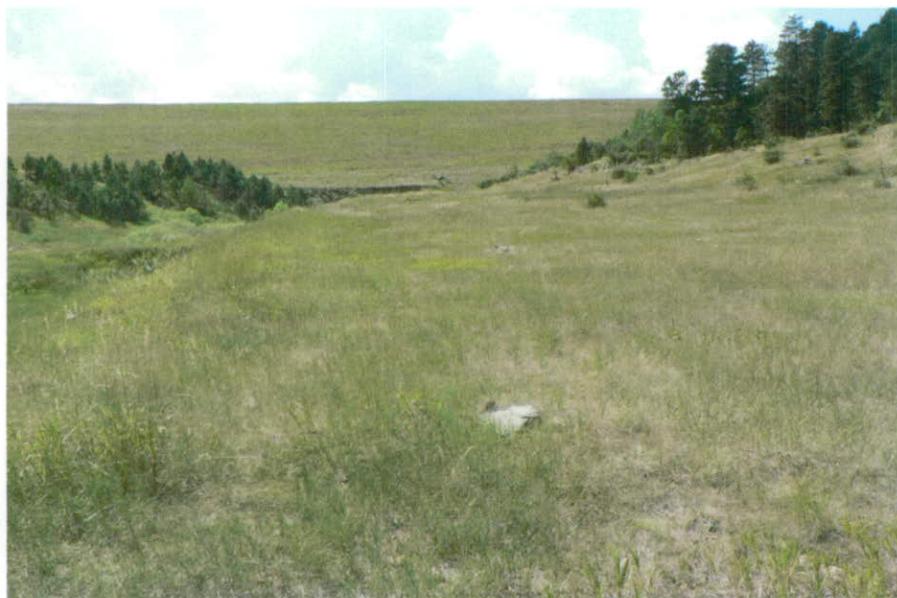
Photo LPC-3 – Leach Pad Corridor, looking toward Leach Pad 3.

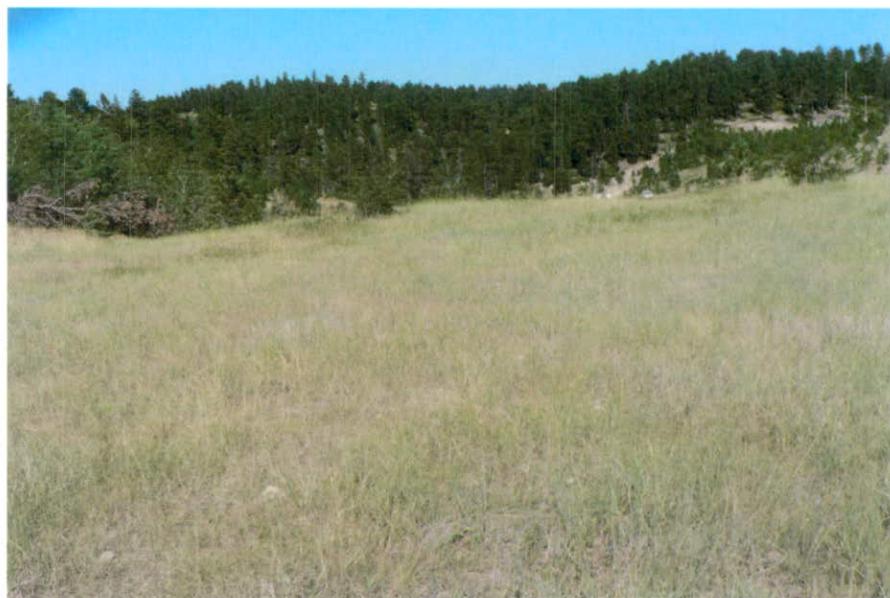
Photo LPC-4 – Leach Pad Corridor, looking north.

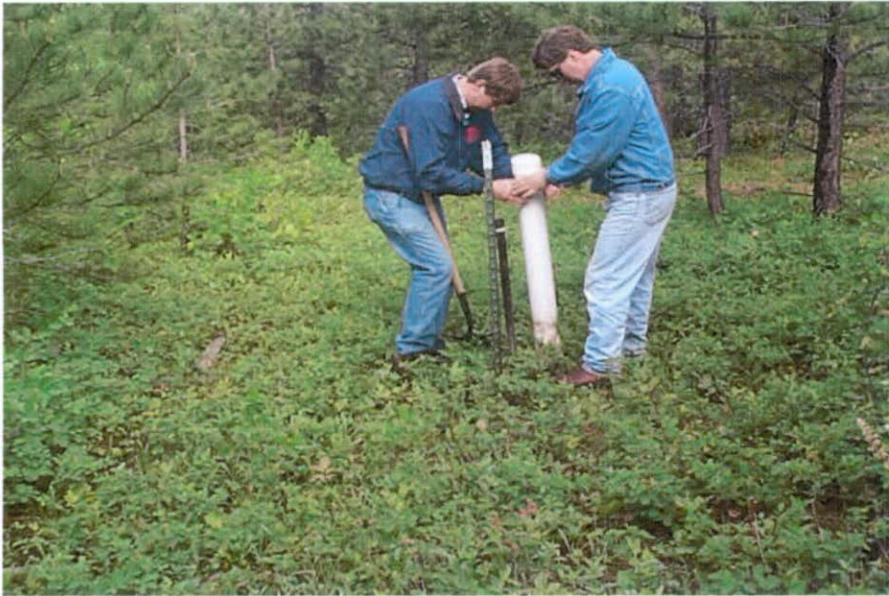
Photo LA-1 – LAC personnel removing tensiometers.

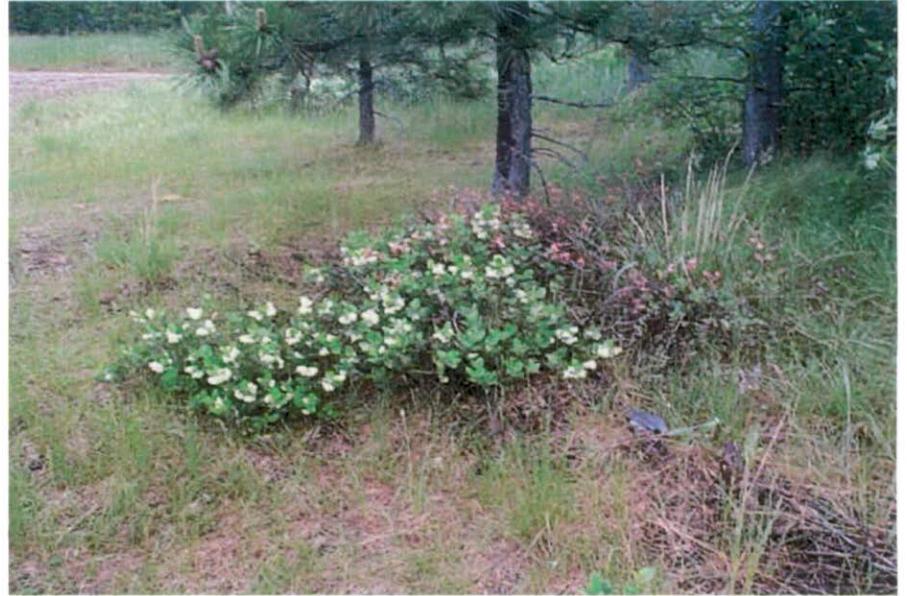
Photo LA-2 – Recovered ceanothus.

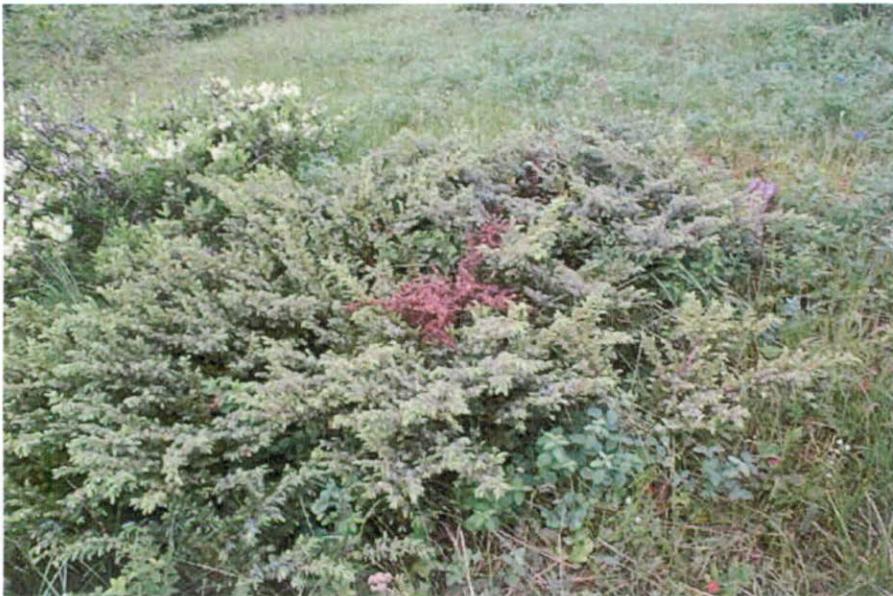
Photo LA-3 – Recovered juniper.

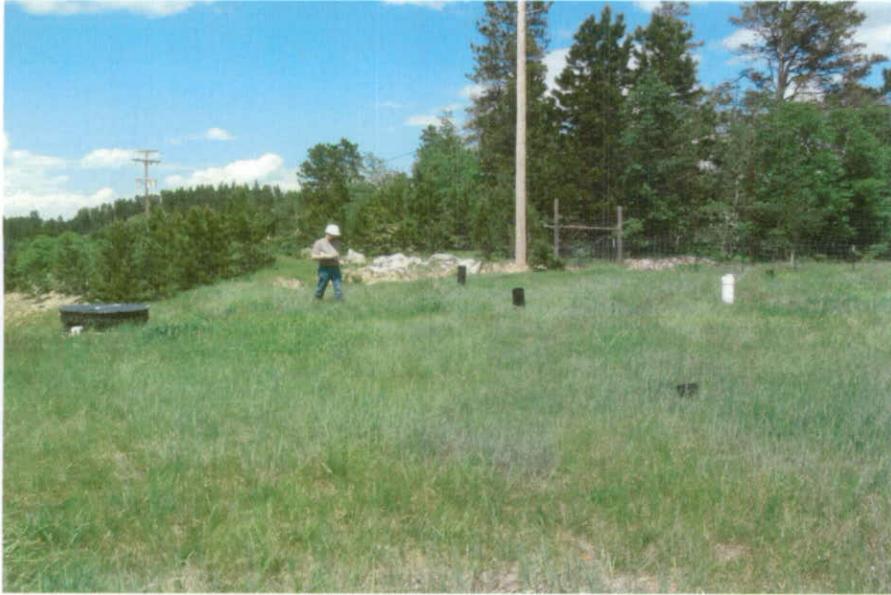
Photo PT-1 – Pipes and vegetative cover from June 24, 2014 inspection.

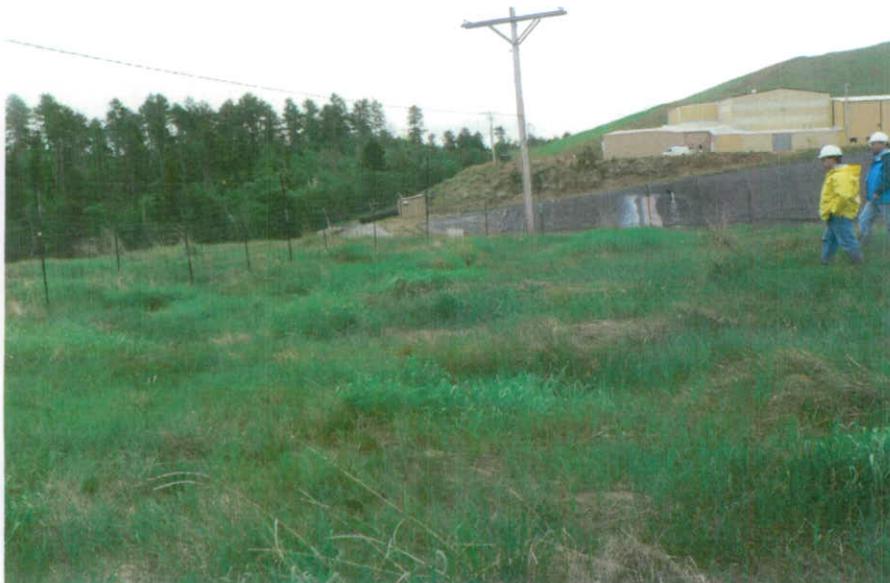
Photo PT-3 – Pipes removed from Passive Treatment Cell.

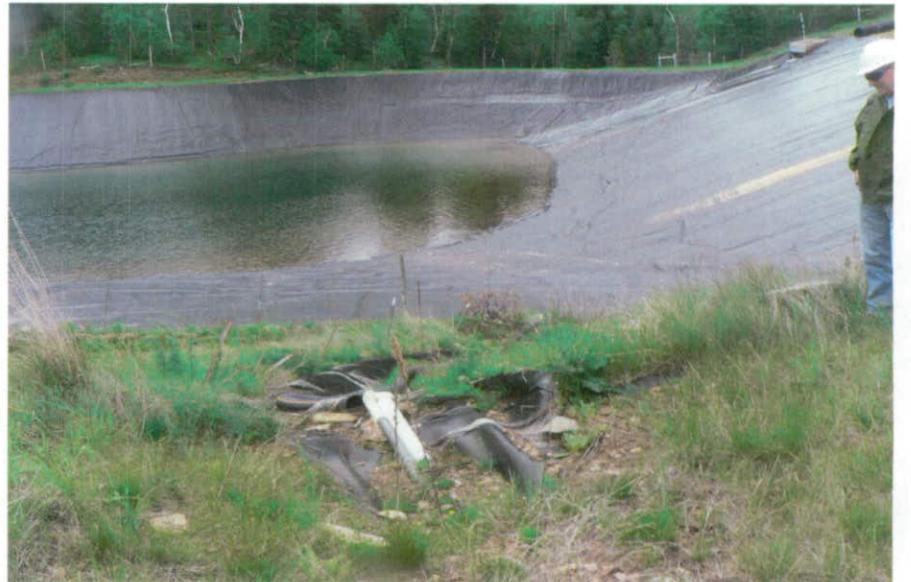
Photo PT-4 – Spillway into Stormwater Pond.
